General Information

Make	Toyota	Model	Rush
YOM	2022	Odo Meter Reading	98,786
Registration No.	NGX5910	Chassis No.	MHKE8FF3PNK041090
CC	1.5	Transmission	A/T
Fuel Type	Gas	Type of Body	SUV
Colour	Red Mica Metallic

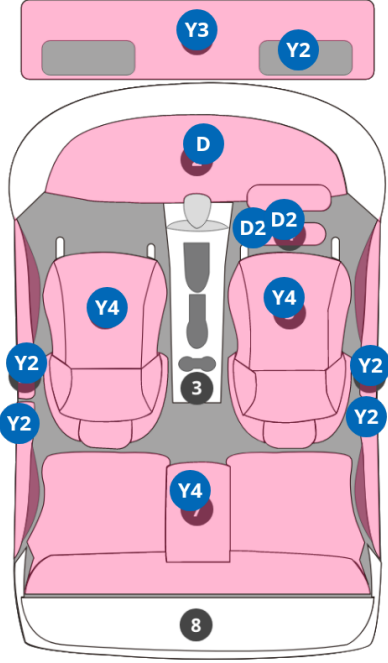
Interior Evaluation : E	Exterior Evaluation : E

<p>a : Cut, Fray d : Loose, Deformed k : Animal Hair s : Smell t : Cigarette Burns x : Defective y : Stain</p>

<p>A : Scratch AU : Scratch & Dent B : Modified C : Corrosion G : Stone chip P : Faded S : Rust SC : Rust & Corrosion U : Dent X : Defective Y : Crack, Gap</p>
Remarks (L) Front Seat - Grime - Large / Dashboard - Traces of Adhesive Tape - Yes / Sunvisor, Sunglass Holder - Grime - Small / (L) Front Trim - Grime - Small / (L) Front Floor Mat - Worked - Small / Rear Seat - Grime - Large / Ceiling - Grime - Medium / (L) Rear Trim - Grime - Small / (R) Rear Trim - Grime - Small / Mat Other - Worked - Small / (R) Front Trim - Grime - Small / (R) Front Seat - Grime - Large	Remarks Roof - Repair Traces - Yes / Roof - Repair mark - Yes / (L) Front Fender, Molding - Scratch - Small / (L) Mirror - Scratch - Small / (L) Front Door, Molding - Scratch - Small / (L) Rear Door, Molding - Scratch - Small / (L) Rear Fender, Molding - Scratch & Dent - Small / Trunk Hood, Rear Gate - Scratch - Small / (R) Rear Fender, Molding - Scratch & Dent - Large / Rear Bumper, Lamps, Panels - Scratch - Small / (R) Rear Door, Molding - Scratch - Medium / (R) Mirror - Scratch - Small / (R) Front Door, Molding - Scratch - Large / (R) Front Fender, Molding - Scratch - Large / Front Bumper, Grille, Lamps - Repair mark - Yes / Front Bumper, Grille, Lamps - Scratch & Dent - Large / Bonnet, Headlight - Scratch - Small

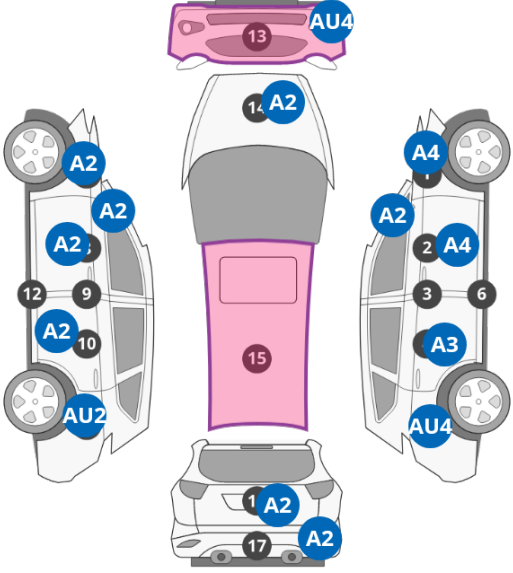
Inspector Notes
Possible flooding. Side mirror switches issue. Roof was wrapped in black. right foglight busted. Left foglight cover repaired. Without warranty booklet, tools, jack and seat cover. With spare tire. 1 key. With LTO plate.
