General Information

Make	Toyota	Model	Vios
YOM	2025	Odo Meter Reading	47,163
Registration No.	DBS1487	Chassis No.	PA1B18F32R4279628
CC	1.3	Transmission	CVT
Fuel Type	Gas	Type of Body	Sedan
Colour	Silver

Body / Panel Condition

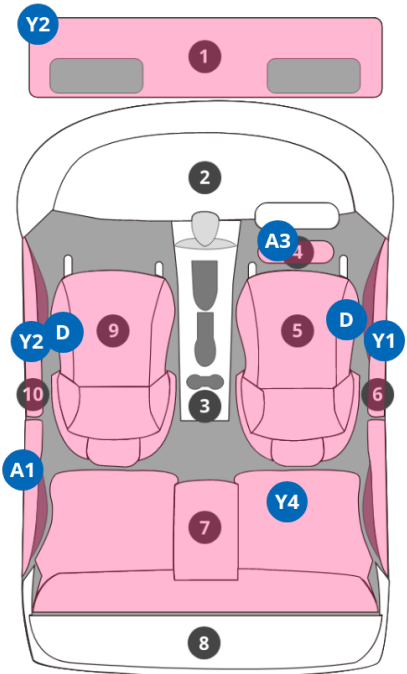
Interior Evaluation : C	Exterior Evaluation : C

<p>a : Cut, Fray d : Loose, Deformed k : Animal Hair s : Smell t : Cigarette Burns x : Defective y : Stain</p>

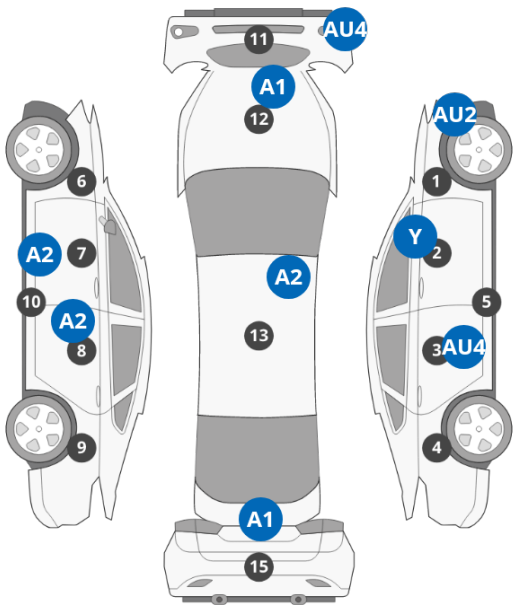
<p>A : Scratch AU : Scratch & Dent B : Modified C : Corrosion G : Stone chip P : Faded S : Rust SC : Rust & Corrosion U : Dent X : Defective Y : Crack, Gap</p>
<p>Remarks (L) Front Floor Mat - Cut, Crack - Medium / Ceiling - Grime - Small / (R) Front Trim - Grime - Minimal / Rear Seat - Grime - Large / (L) Front Seat - Worn - Yes / (R) Front Seat - Worn - Yes / (L) Front Trim - Grime - Small / (L) Rear Trim - Cut, Crack - Minimal</p>	<p>Remarks (R) Front Fender, Molding - Scratch & Dent - Small / (R) Mirror - Crack - Damaged / (R) Rear Door, Molding - Scratch & Dent - Large / Trunk Hood, Rear Gate - Scratch - Minimal / (L) Rear Door, Molding - Scratch - Small / (L) Front Door, Molding - Scratch - Small / Front Bumper, Grille, Lamps - Scratch & Dent - Large / Bonnet, Headlight - Scratch - Minimal / Roof - Scratch - Small</p>
