General Information

Make	Toyota	Model	Vios
YOM	2025	Odo Meter Reading	15,182
Registration No.	GBK6966	Chassis No.	PA1B18F3XS4290771
CC	1.3	Transmission	CVT
Fuel Type	Gas	Type of Body	Sedan
Colour	Red Mica Metallic

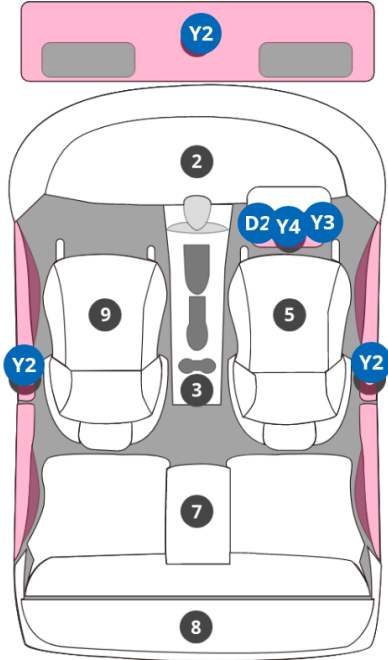
Interior Evaluation : C	Exterior Evaluation : E

<p>a : Cut, Fray d : Loose, Deformed k : Animal Hair s : Smell t : Cigarette Burns x : Defective y : Stain</p>

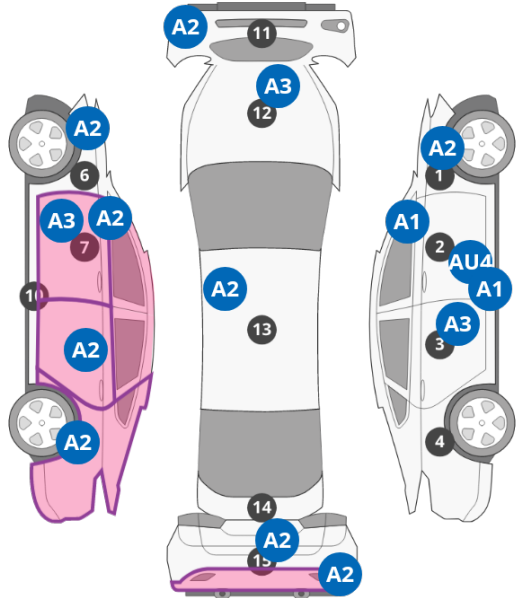
<p>A : Scratch AU : Scratch & Dent B : Modified C : Corrosion G : Stone chip P : Faded S : Rust SC : Rust & Corrosion U : Dent X : Defective Y : Crack, Gap</p>
<p>Remarks (L) Front Trim - Grime - Small / (L) Front Floor Mat - Worked - Small / Ceiling - Grime - Small / Mat Other - Grime - Large / (R) Front Trim - Grime - Small / (R) Front Floor Mat - Grime - Medium</p>	<p>Remarks (L) Front Door - Repair Traces - Yes / (L) Step - Repair Traces - Yes / (L) Rear Door - Repair Traces - Yes / (L) Front Fender, Molding - Scratch - Small / (L) Mirror - Scratch - Small / (L) Front Door, Molding - Scratch - Medium / (L) Front Door, Molding - Repair mark - Yes / (L) Rear Door, Molding - Repair mark - Yes / (L) Rear Fender, Molding - Repair mark - Yes / (L) Rear Door, Molding - Scratch - Small / (L) Rear Fender, Molding - Scratch - Small / Rear Bumper, Lamps, Panels - Repair mark - Yes / Rear Bumper, Lamps, Panels - Scratch - Small / Trunk Hood, Rear Gate - Scratch - Small / (R) Rear Door, Molding - Scratch - Medium / (R) Front Door, Molding - Scratch & Dent - Large / (R) Mirror - Scratch - Minimal / (R) Front Fender, Molding - Scratch - Small / (R) Step, In-panel, Side Spoiler - Scratch - Minimal / Bonnet, Headlight - Scratch - Medium / Front Bumper, Grille, Lamps - Scratch - Small / Roof - Scratch - Small</p>
