General Information

| Make | Toyota | Model | Vios |

Body / Panel Condition

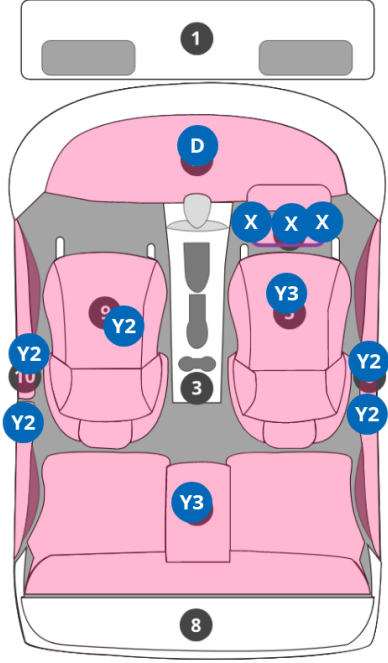
| Interior Evaluation : C | Exterior Evaluation : E |

| <p>Remarks (R) Front Trim - Grime - Small / (R) Front Seat - Grime - Medium / (R) Front Floor Mat - Missing - Yes / Mat Other - Missing - Yes / Rear Seat - Grime - Medium / (R) Rear Trim - Grime - Small / (L) Rear Trim - Grime - Small / (L) Front Trim - Grime - Small / (L) Front Seat - Grime - Small / Dashboard - Traces of Adhesive Tape - Yes / (L) Front Floor Mat - Missing - Yes</p> | <p>Remarks (R) Front Fender, Molding - Scratch & Dent - Large / (R) Mirror - Scratch - Minimal / (R) Front Door, Molding - Scratch - Medium / (R) Rear Door, Molding - Scratch - Small / (R) Rear Fender, Molding - Scratch - Small / Trunk Hood, Rear Gate - Scratch & Dent - Medium / Rear Bumper, Lamps, Panels - Scratch - Large / (L) Rear Fender, Molding - Scratch - Small / (L) Rear Door, Molding - Scratch - Small / (L) Mirror - Scratch - Small / (L) Front Door, Molding - Scratch - Medium / (L) Front Fender, Molding - Scratch - Small / Bonnet, Headlight - Scratch - Small / Front Bumper, Grille, Lamps - Scratch - Medium / Roof - Scratch - Small</p> |
