General Information

Make	Toyota	Model	Wigo
YOM	2024	Odo Meter Reading	25,757
Registration No.	GBC7454	Chassis No.	MHKAA1BC7RJ015252
CC	1.0	Transmission	CVT
Fuel Type	Gas	Type of Body	Hatchback
Colour	Orange

Body / Panel Condition

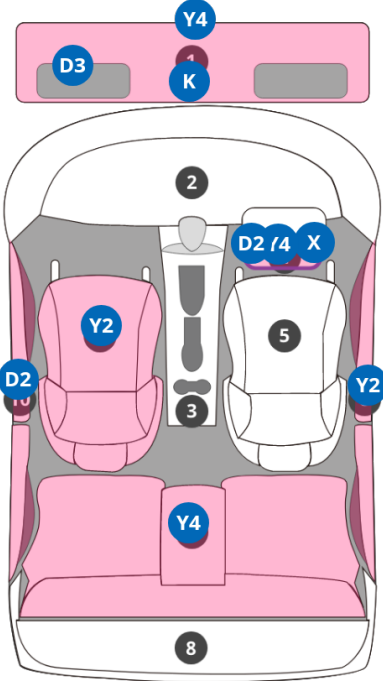
Interior Evaluation : C	Exterior Evaluation : E

<p>a : Cut, Fray d : Loose, Deformed k : Animal Hair s : Smell t : Cigarette Burns x : Defective y : Stain</p>

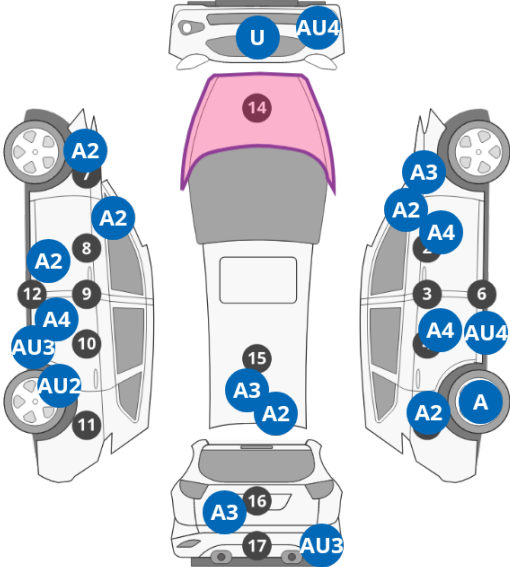
<p>A : Scratch AU : Scratch & Dent B : Modified C : Corrosion G : Stone chip P : Faded S : Rust SC : Rust & Corrosion U : Dent X : Defective Y : Crack, Gap</p>
<p>Remarks (R) Front Floor Mat - Missing - Yes / (R) Front Trim - Grime - Small / Mat Other - Grime - Large / Overall Interior - Animal Hair - Yes / Ceiling - Grime - Large / Rear Seat - Grime - Large / (L) Front Seat - Grime - Small / (L) Front Floor Mat - Worked - Small / (L) Front Trim - Worked - Small / Sunvisor, Sunglass Holder - Crinkle - Medium</p>	<p>Remarks (R) Front Fender - Repair Traces - Yes / Bonnet - Repair Traces - Yes / (L) Front Fender - Repair Traces - Yes / Bonnet, Headlight - Repair mark - Difference in Color / (R) Front Fender, Molding - Scratch - Medium / (R) Front Door, Molding - Scratch - Large / (R) Step, In-panel, Side Spoiler - Scratch & Dent - Large / (R) Rear Door, Molding - Scratch - Large / (R) Rear Fender, Molding - Scratch - Small / Trunk Hood, Rear Gate - Scratch - Medium / Rear Bumper, Lamps, Panels - Scratch & Dent - Medium / (R) Rear Tyre - Crack, Cut - Yes / (L) Rear Fender, Molding - Scratch & Dent - Small / (L) Step, In-panel, Side Spoiler - Scratch & Dent - Medium / (L) Rear Door, Molding - Scratch - Large / (L) Mirror - Scratch - Small / (L) Front Door, Molding - Scratch - Small / (L) Front Fender, Molding - Scratch - Small / Front Bumper, Grille, Lamps - Scratch & Dent - Large / (R) Mirror - Scratch - Small / Roof - Scratch - Medium / Roof Spoiler, Molding - Scratch - Small / Member (Bolted) - Dent - Yes</p>
