General Information

Make	Toyota	Model	Vios
YOM	2023	Odo Meter Reading	24,846
Registration No.	FAP7244	Chassis No.	PA1B18F31P4224553
CC	1.3	Transmission	CVT
Fuel Type	Gas	Type of Body	Sedan
Colour	Blue

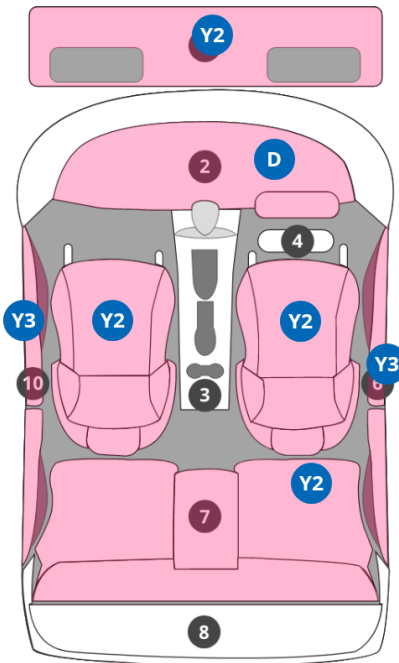
Interior Evaluation : B	Exterior Evaluation : C

<p>a : Cut, Fray d : Loose, Deformed k : Animal Hair s : Smell t : Cigarette Burns x : Defective y : Stain</p>

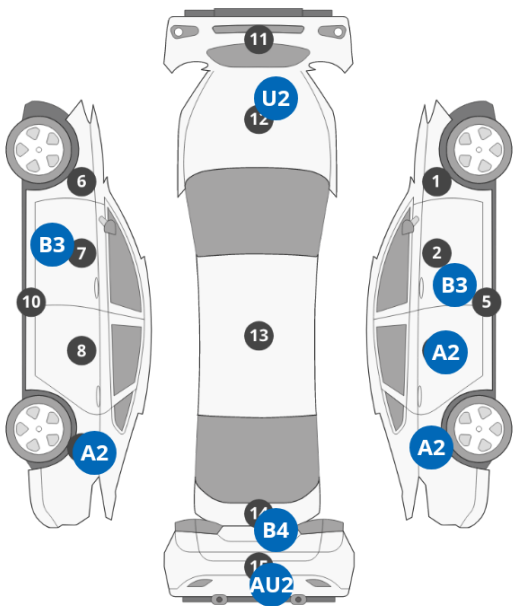
<p>A : Scratch AU : Scratch & Dent B : Modified C : Corrosion G : Stone chip P : Faded S : Rust SC : Rust & Corrosion U : Dent X : Defective Y : Crack, Gap</p>
Remarks (R) Front Trim - Grime - Medium / (R) Front Seat - Grime - Small / (L) Front Seat - Grime - Small / Rear Seat - Grime - Small / Ceiling - Grime - Small / Dashboard - Traces of Adhesive Tape - Yes / (L) Front Trim - Grime - Medium	Remarks (R) Front Door - Repair Traces - Yes / (R) Step - Repair Traces - Yes / (R) Front Fender - Repair Traces - Yes / Bonnet - Repair Traces - Yes / Trunk Hood, Rear Gate - Modified - Large / (R) Rear Fender, Molding - Scratch - Small / Rear Bumper, Lamps, Panels - Scratch & Dent - Small / (L) Front Door, Molding - Modified - Medium / (R) Front Door, Molding - Modified - Medium / (R) Rear Door, Molding - Scratch - Small / Bonnet, Headlight - Dent - Small / (L) Rear Fender, Molding - Scratch - Small
