General Information

Make	Toyota	Model	Wigo
YOM	2025	Odo Meter Reading	11,834
Registration No.	DBU6067	Chassis No.	MHKAA1BC9SJ035573
CC	1.0	Transmission	M/T
Fuel Type	Gas	Type of Body	Hatchback
Colour	Silver

Body / Panel Condition

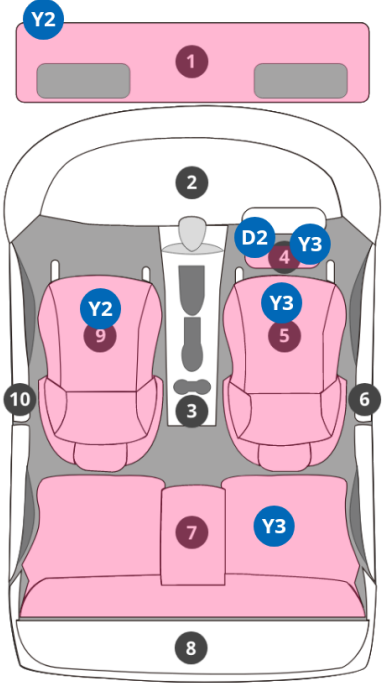
Interior Evaluation : B	Exterior Evaluation : C

<p>a : Cut, Fray d : Loose, Deformed k : Animal Hair s : Smell t : Cigarette Burns x : Defective y : Stain</p>

<p>A : Scratch AU : Scratch & Dent B : Modified C : Corrosion G : Stone chip P : Faded S : Rust SC : Rust & Corrosion U : Dent X : Defective Y : Crack, Gap</p>
<p>Remarks (L) Front Seat - Grime - Small / (R) Front Seat - Grime - Medium / Rear Seat - Grime - Medium / (R) Front Floor Mat - Grime - Medium / (L) Front Floor Mat - Worked - Small / Ceiling - Grime - Small</p>	<p>Remarks (R) Mirror - Scratch - Minimal / (R) Front Fender, Molding - Scratch - Minimal / (R) Front Door, Molding - Scratch - Small / (R) Rear Door, Molding - Scratch - Small / (R) Rear Fender, Molding - Scratch - Minimal / Rear Bumper, Lamps, Panels - Scratch - Small / Trunk Hood, Rear Gate - Scratch - Minimal / (L) Rear Fender, Molding - Scratch - Small / (L) Step, In-panel, Side Spoiler - Scratch - Small / (L) Front Door, Molding - Scratch - Medium / (L) Rear Door, Molding - Scratch - Small / (L) Mirror - Scratch - Minimal / (L) Front Fender, Molding - Scratch - Small / Front Bumper, Grille, Lamps - Scratch - Small / Bonnet, Headlight - Scratch - Small / Roof - Scratch - Small</p>

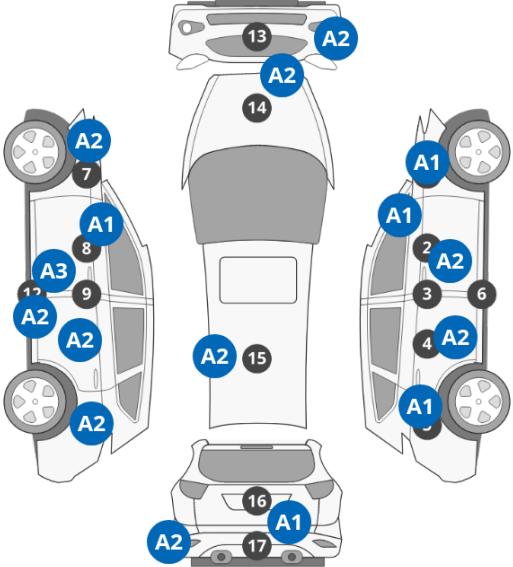
<p>Inspector Notes</p>
<p>no warranty booklet, with jack and tools, with spare tire, with LTO plate, scratches on tail light</p>
