General Information

Make	Toyota	Model	Vios
YOM	2025	Odo Meter Reading	58,910
Registration No.	NKH3619	Chassis No.	PA1B18F34R4275872
CC	1.3	Transmission	CVT
Fuel Type	Gas	Type of Body	Sedan
Colour	Red Mica Metallic

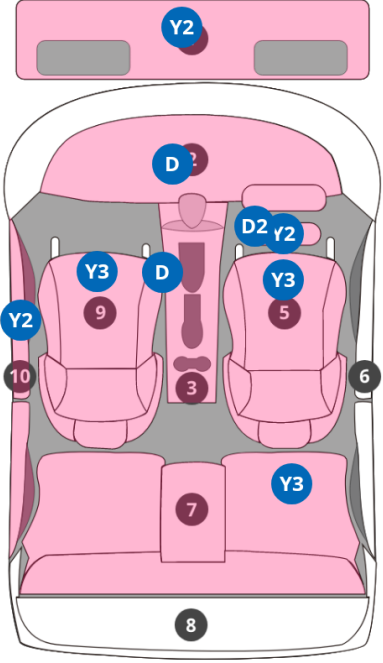
Interior Evaluation : C	Exterior Evaluation : E

<p>a : Cut, Fray d : Loose, Deformed k : Animal Hair s : Smell t : Cigarette Burns x : Defective y : Stain</p>

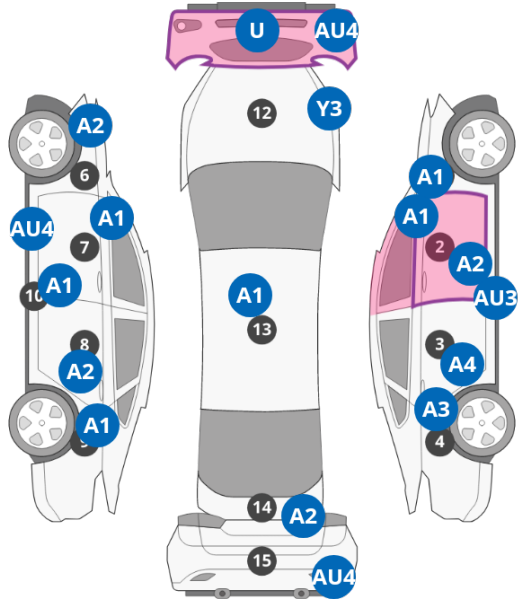
<p>A : Scratch AU : Scratch & Dent B : Modified C : Corrosion G : Stone chip P : Faded S : Rust SC : Rust & Corrosion U : Dent X : Defective Y : Crack, Gap</p>
<p>Remarks (L) Front Seat - Grime - Medium / (R) Front Seat - Grime - Medium / (L) Front Trim - Grime - Small / Mat Other - Grime - Small / (L) Front Floor Mat - Worked - Small / Rear Seat - Grime - Medium / Dashboard - Traces of Adhesive Tape - Yes / Ceiling - Grime - Small / Console, Switchs, Vents - Traces of Adhesive Tape - Yes</p>	<p>Remarks (R) Front Fender - Repair Traces - Yes / Bonnet - Repair Traces - Yes / (L) Front Fender - Repair Traces - Yes / Member (Bolted) - Dent - Yes / (R) Front Door, Molding - Repair mark - Yes / (R) Mirror - Scratch - Minimal / (R) Front Fender, Molding - Scratch - Minimal / (R) Step, In-panel, Side Spoiler - Scratch & Dent - Medium / (R) Front Door, Molding - Scratch - Small / (R) Rear Door, Molding - Scratch - Large / (R) Rear Fender, Molding - Scratch - Medium / Rear Bumper, Lamps, Panels - Scratch & Dent - Large / Trunk Hood, Rear Gate - Scratch - Small / (L) Rear Fender, Molding - Scratch - Minimal / (L) Step, In-panel, Side Spoiler - Scratch & Dent - Large / (L) Front Door, Molding - Scratch - Minimal / (L) Rear Door, Molding - Scratch - Small / (L) Mirror - Scratch - Minimal / (L) Front Fender, Molding - Scratch - Small / Front Bumper, Grille, Lamps - Repair mark - Yes / Front Bumper, Grille, Lamps - Scratch & Dent - Large / Bonnet, Headlight - Crack, Gap - Medium / Roof - Scratch - Minimal</p>

<p>Inspector Notes</p>
<p>no warranty booklet and jack, incomplete tools, with spare tire, with LTO plate, scratched and cracked tail light, possible flooding,</p>
