General Information

Make	Toyota	Model	Vios
YOM	2024	Odo Meter Reading	38,342
Registration No.	CAZ8311	Chassis No.	PA1B18F34P4237149
CC	1.3	Transmission	CVT
Fuel Type	Gas	Type of Body	Sedan
Colour	Green

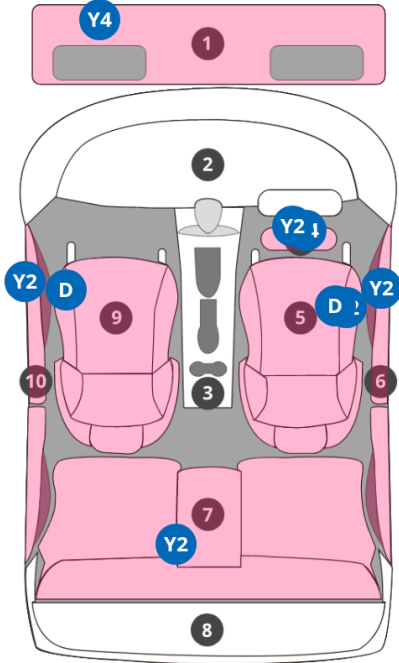
Interior Evaluation : C	Exterior Evaluation : E

<p>a : Cut, Fray d : Loose, Deformed k : Animal Hair s : Smell t : Cigarette Burns x : Defective y : Stain</p>

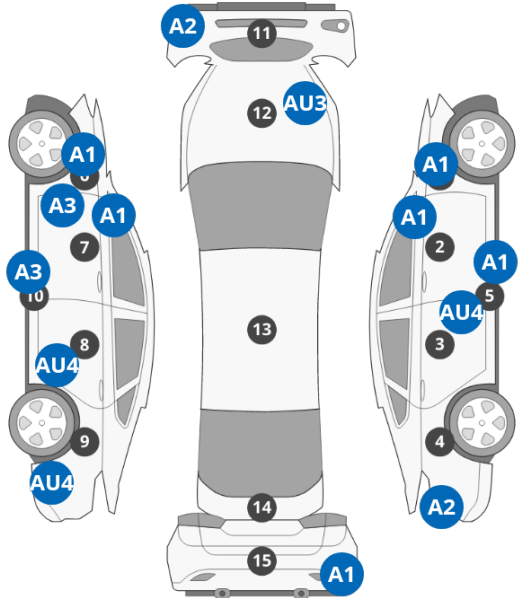
<p>A : Scratch AU : Scratch & Dent B : Modified C : Corrosion G : Stone chip P : Faded S : Rust SC : Rust & Corrosion U : Dent X : Defective Y : Crack, Gap</p>
<p>Remarks Ceiling - Grime - Large / (L) Front Floor Mat - Worked - Large / (R) Front Trim - Grime - Small / (L) Front Trim - Grime - Small / Rear Seat - Grime - Small / (R) Front Floor Mat - Grime - Small / (R) Front Seat Head Rest - Worked - Small / (L) Front Seat - Worn - Yes / (R) Front Seat - Worn - Yes</p>	<p>Remarks (R) Front Fender, Molding - Scratch - Minimal / (R) Step, In-panel, Side Spoiler - Scratch - Minimal / (R) Mirror - Scratch - Minimal / (R) Rear Door, Molding - Scratch & Dent - Large / (R) Rear Fender, Molding - Scratch - Small / Rear Bumper, Lamps, Panels - Scratch - Minimal / (L) Rear Fender, Molding - Scratch & Dent - Large / (L) Rear Door, Molding - Scratch & Dent - Large / (L) Step, In-panel, Side Spoiler - Scratch - Medium / (L) Mirror - Scratch - Minimal / (L) Front Door, Molding - Scratch - Medium / (L) Front Fender, Molding - Scratch - Minimal / Bonnet, Headlight - Scratch & Dent - Medium / Front Bumper, Grille, Lamps - Scratch - Small</p>
