General Information

Make	Toyota	Model	Vios
YOM	2021	Odo Meter Reading	206,428
Registration No.	DAU9876	Chassis No.	PA1B18F37M4142676
CC	1.3	Transmission	CVT
Fuel Type	Gas	Type of Body	Sedan
Colour	Red

Body / Panel Condition

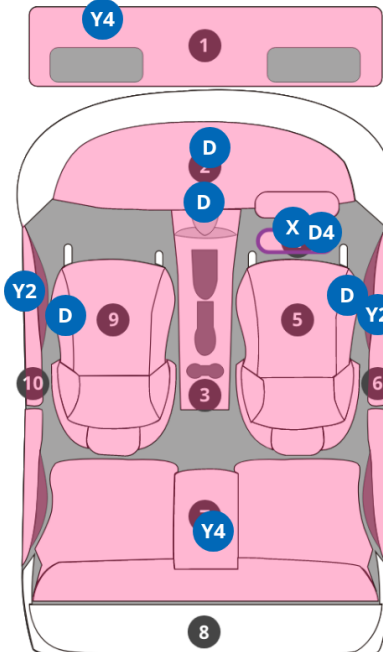
Interior Evaluation : D	Exterior Evaluation : E

<p>a : Cut, Fray d : Loose, Deformed k : Animal Hair s : Smell t : Cigarette Burns x : Defective y : Stain</p>

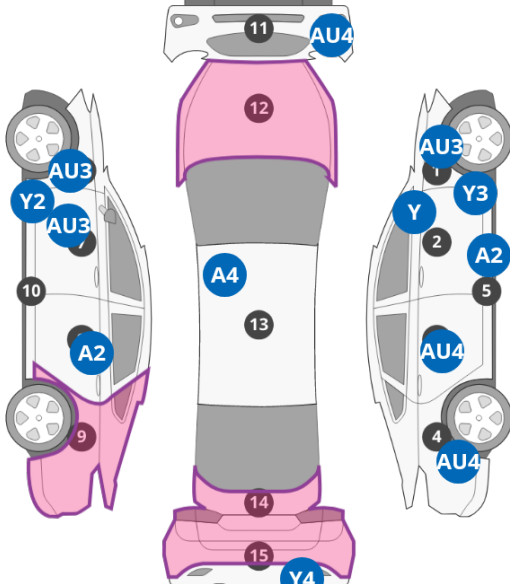
<p>A : Scratch AU : Scratch & Dent B : Modified C : Corrosion G : Stone chip P : Faded S : Rust SC : Rust & Corrosion U : Dent X : Defective Y : Crack, Gap</p>
<p>Remarks Ceiling - Grime - Large / Dashboard - Traces of Adhesive Tape - Yes / (R) Front Floor Mat - Missing - Yes / (L) Front Floor Mat - Worked - Large / (L) Front Trim - Grime - Small / (R) Front Trim - Grime - Small / (L) Front Seat - Worn - Yes / (R) Front Seat - Worn - Yes / Rear Seat - Grime - Large / Console, Switches, Vents - Traces of Adhesive Tape - Yes</p>	<p>Remarks Bonnet - Repair Traces - Yes / (L) Step - Repair Traces - Yes / (L) Rear Door - Repair Traces - Yes / Trunk Hood, Rear Gate - Repair Traces - Yes / (R) Rear Door - Repair Traces - Yes / (R) Front Fender, Molding - Scratch & Dent - Medium / (R) Mirror - Crack - Damaged / (R) Front Door, Molding - Crack, Gap - Medium / (R) Step, In-panel, Side Spoiler - Scratch - Small / (R) Rear Door, Molding - Scratch & Dent - Large / (R) Rear Fender, Molding - Scratch & Dent - Large / Rear Bumper, Lamps, Panels - Crack, Gap - Large / (L) Rear Fender, Molding - Repair mark - Difference in Color / (L) Rear Door, Molding - Scratch - Small / (L) Front Door, Molding - Scratch & Dent - Medium / (L) Step, In-panel, Side Spoiler - Crack, Gap - Small / (L) Front Fender, Molding - Scratch & Dent - Medium / Front Bumper, Grille, Lamps - Scratch & Dent - Large / Bonnet, Headlight - Repair mark - Difference in Color / Trunk Hood, Rear Gate - Repair mark - Difference in Color / Roof - Scratch - Large</p>
