General Information

Make	Toyota	Model	Vios
YOM	2021	Odo Meter Reading	170,741
Registration No.	DAV5538	Chassis No.	PA1B18F37M4149269
CC	1.3	Transmission	CVT
Fuel Type	Gas	Type of Body	Sedan
Colour	Red

Body / Panel Condition

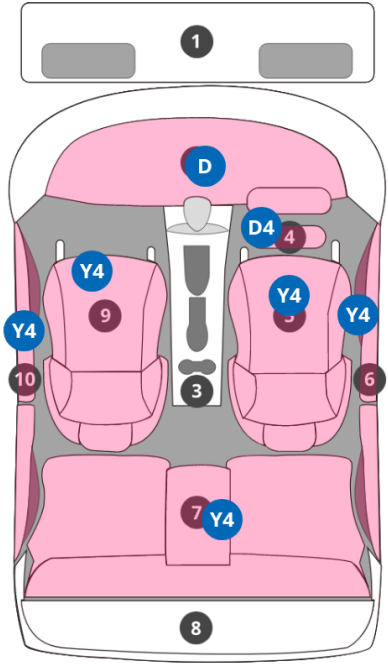
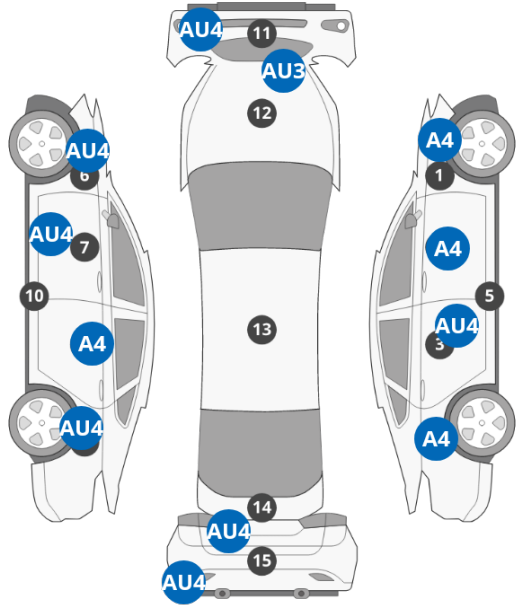
Interior Evaluation :	E	Exterior Evaluation :	E

<p>a : Cut, Fray d : Loose, Deformed k : Animal Hair s : Smell t : Cigarette Burns x : Defective y : Stain</p>		<p>A : Scratch AU : Scratch & Dent B : Modified C : Corrosion G : Stone chip P : Faded S : Rust SC : Rust & Corrosion U : Dent X : Defective Y : Crack, Gap</p>	
<p>Remarks (R) Front Seat - Grime - Large / (R) Front Trim - Grime - Large / Rear Seat - Grime - Large / (L) Front Trim - Grime - Large / (L) Front Seat - Grime - Large / (L) Front Floor Mat - Worked - Large / Dashboard - Traces of Adhesive Tape - Yes</p>		<p>Remarks (R) Front Fender - Repair Traces - Yes / Trunk Hood, Rear Gate - Scratch & Dent - Large / Rear Bumper, Lamps, Panels - Scratch & Dent - Large / (L) Rear Fender, Molding - Scratch & Dent - Large / (L) Rear Door, Molding - Scratch - Large / (L) Front Door, Molding - Scratch & Dent - Large / (L) Front Fender, Molding - Scratch & Dent - Large / Front Bumper, Grille, Lamps - Scratch & Dent - Large / Bonnet, Headlight - Scratch & Dent - Medium / (R) Front Fender, Molding - Scratch - Large / (R) Front Door, Molding - Scratch - Large / (R) Rear Door, Molding - Scratch & Dent - Large / (R) Rear Fender, Molding - Scratch - Large</p>
