General Information

Make	Toyota	Model	Vios
YOM	2025	Odo Meter Reading	13,210
Registration No.	DBQ8128	Chassis No.	PA1B18F35R4273841
CC	1.3	Transmission	CVT
Fuel Type	Gas	Type of Body	Sedan
Colour	Red Mica Metallic

Body / Panel Condition

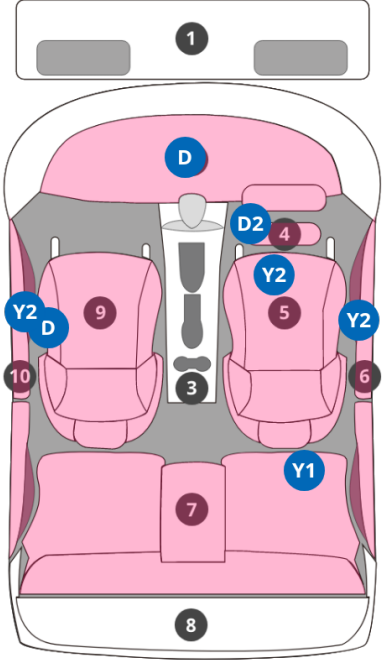
Interior Evaluation : B	Exterior Evaluation : C

<p>a : Cut, Fray d : Loose, Deformed k : Animal Hair s : Smell t : Cigarette Burns x : Defective y : Stain</p>

<p>A : Scratch AU : Scratch & Dent B : Modified C : Corrosion G : Stone chip P : Faded S : Rust SC : Rust & Corrosion U : Dent X : Defective Y : Crack, Gap</p>
<p>Remarks (R) Front Seat - Grime - Small / (L) Front Floor Mat - Worked - Small / (L) Front Seat - Worn - Yes / (R) Front Trim - Grime - Small / (L) Front Trim - Grime - Small / Rear Seat - Grime - Minimal / Dashboard - Traces of Adhesive Tape - Yes</p>	<p>Remarks (R) Mirror - Scratch - Minimal / (R) Front Fender, Molding - Scratch - Minimal / (R) Front Door, Molding - Scratch - Large / (R) Rear Fender, Molding - Scratch - Small / Trunk Hood, Rear Gate - Scratch - Small / Rear Bumper, Lamps, Panels - Scratch & Dent - Small / (L) Rear Door, Molding - Dent - Small / (L) Rear Fender, Molding - Scratch - Minimal / (L) Front Door, Molding - Scratch & Dent - Small / (L) Mirror - Scratch - Minimal / (L) Front Fender, Molding - Scratch - Minimal / Front Bumper, Grille, Lamps - Scratch - Small / Roof - Scratch - Small / (R) Rear Door, Molding - Scratch - Medium</p>

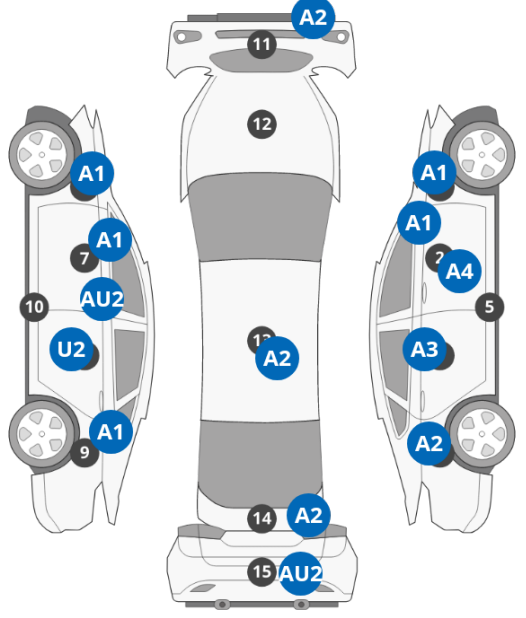
<p>Inspector Notes</p>
<p>no warranty booklet, tools and spare tire, with jack and LTO plate, scratches on tail light</p>
