General Information

Make	Toyota	Model	Wigo
YOM	2025	Odo Meter Reading	10,975
Registration No.	DBR2385	Chassis No.	MHKAA1BC9RJ025958
CC	1.0	Transmission	CVT
Fuel Type	Gas	Type of Body	Hatchback
Colour	Silver

Body / Panel Condition

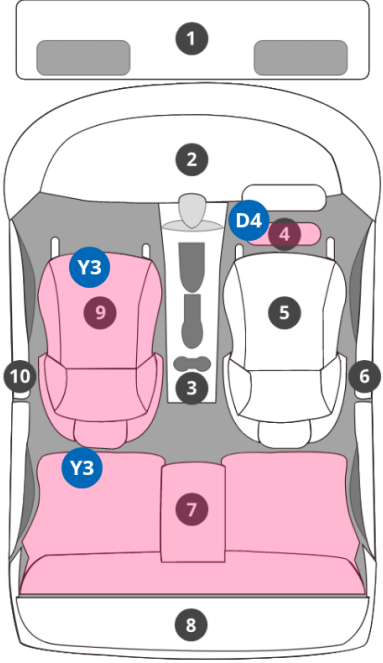
Interior Evaluation : C	Exterior Evaluation : C

<p>a : Cut, Fray d : Loose, Deformed k : Animal Hair s : Smell t : Cigarette Burns x : Defective y : Stain</p>

<p>A : Scratch AU : Scratch & Dent B : Modified C : Corrosion G : Stone chip P : Faded S : Rust SC : Rust & Corrosion U : Dent X : Defective Y : Crack, Gap</p>
<p>Remarks Rear Seat - Grime - Medium / (L) Front Floor Mat - Worked - Large / (L) Front Seat - Grime - Medium</p>	<p>Remarks Front Bumper, Grille, Lamps - Scratch & Dent - Large / (L) Front Fender, Molding - Scratch & Dent - Small / (L) Mirror - Scratch - Minimal / (L) Front Door, Molding - Scratch - Small / Rear Bumper, Lamps, Panels - Scratch & Dent - Small / Trunk Hood, Rear Gate - Scratch - Small / (R) Rear Door, Molding - Dent - Small / (R) Front Fender, Molding - Dent - Small / (R) Front Door, Molding - Scratch - Small / Bonnet, Headlight - Scratch - Medium / (L) Rear Door, Molding - Scratch & Dent - Small / (L) Rear Fender, Molding - Scratch & Dent - Small</p>
