## General Information

| Make | Toyota | Model | Vios |
| YOM | 2017 | Mileage | 71,175 |

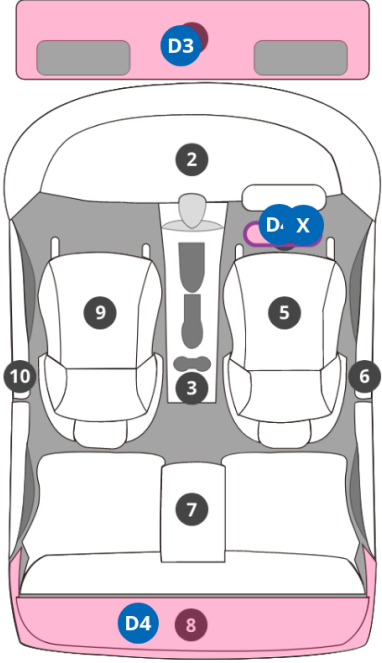
| Interior Evaluation : <span style="color: red;">C</span> | Exterior Evaluation : <span style="color: red;">D</span> |
|---|---|
| <p><b>Remarks</b></p> <p>Trunk Room - Loose, Deformed - Large / (L) Front Floor Mat - Worked - Large / (R) Front Floor Mat - Missing - Yes / Ceiling - Crinkle - Medium</p> | <p><b>Remarks</b></p> <p>Trunk Hood, Rear Gate - Repair Traces - Yes / (R) Front Door, Molding - Scratch - Small / (R) Rear Door, Molding - Scratch &amp; Dent - Medium / (R) Rear Fender, Molding - Dent - Small / Trunk Hood, Rear Gate - Dent - Small / Rear Bumper, Lamps, Panels - Scratch &amp; Dent - Large / (L) Rear Fender, Molding - Scratch - Medium / (L) Rear Door, Molding - Repair mark - Difference in Color / (L) Rear Door, Molding - Scratch &amp; Dent - Large / Front Bumper, Grille, Lamps - Crack, Gap - Small / Bonnet, Headlight - Scratch - Medium</p> |
