General Information

Make	Toyota	Model	Wigo
YOM	2025	Odo Meter Reading	6,943
Registration No.	DBU8831	Chassis No.	MHKAA1BC4SJ038560
CC	1.0	Transmission	CVT
Fuel Type	Gas	Type of Body	Hatchback
Colour	Gray

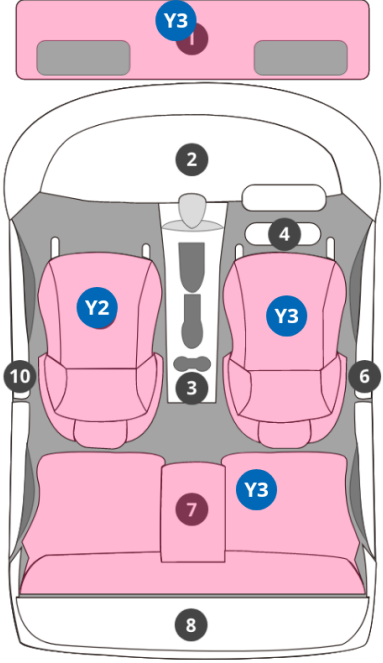
<p>a : Cut, Fray d : Loose, Deformed k : Animal Hair s : Smell t : Cigarette Burns x : Defective y : Stain</p>

<p>A : Scratch AU : Scratch & Dent B : Modified C : Corrosion G : Stone chip P : Faded S : Rust SC : Rust & Corrosion U : Dent X : Defective Y : Crack, Gap</p>
<p>Remarks (R) Front Seat - Grime - Medium / Rear Seat - Grime - Medium / (L) Front Seat - Grime - Small / Ceiling - Grime - Medium</p>	<p>Remarks (L) Front Fender, Molding - Scratch - Minimal / (L) Mirror - Scratch - Minimal / (L) Front Door, Molding - Scratch - Minimal / Trunk Hood, Rear Gate - Scratch - Small / Rear Bumper, Lamps, Panels - Scratch - Small / (R) Rear Fender, Molding - Scratch - Small / (R) Rear Door, Molding - Scratch - Medium / (R) Front Door, Molding - Scratch - Large / (R) Front Fender, Molding - Scratch - Medium / Bonnet, Headlight - Scratch - Medium / Front Bumper, Grille, Lamps - Scratch - Medium / (L) Rear Fender, Molding - Scratch - Minimal / (L) Rear Door, Molding - Scratch - Minimal / Roof - Scratch - Minimal</p>
