General Information

Make	Toyota	Model	Avanza
YOM	2025	Odo Meter Reading	6,132
Registration No.	DBU6437	Chassis No.	MHFAA1BYXS0041592
CC	1.3	Transmission	CVT
Fuel Type	Gas	Type of Body	Wagon
Colour	Silver

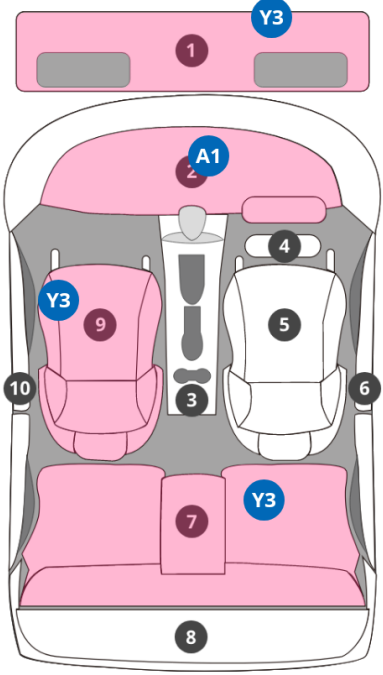
Interior Evaluation : B	Exterior Evaluation : D

<p>a : Cut, Fray d : Loose, Deformed k : Animal Hair s : Smell t : Cigarette Burns x : Defective y : Stain</p>

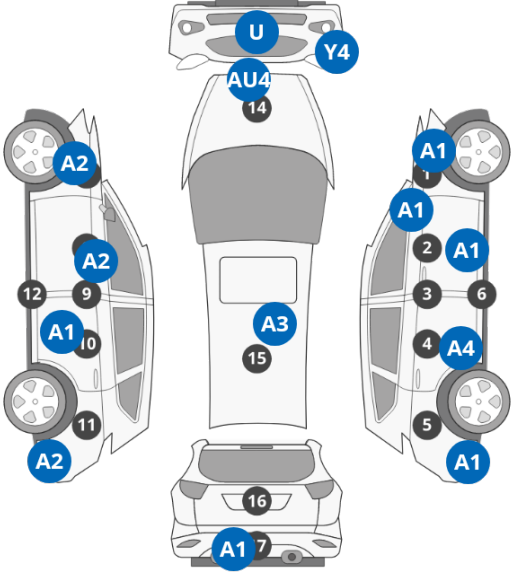
<p>A : Scratch AU : Scratch & Dent B : Modified C : Corrosion G : Stone chip P : Faded S : Rust SC : Rust & Corrosion U : Dent X : Defective Y : Crack, Gap</p>
<p>Remarks Glove Box - Worn, Scratch, Cut, Crack - Minimal / Ceiling - Grime - Medium / (L) Front Seat - Grime - Medium / Rear Seat - Grime - Medium</p>	<p>Remarks (R) Rear Fender - Repair Traces - Yes / Front Bumper, Grille, Lamps - Crack, Gap - Large / (R) Front Fender, Molding - Scratch - Minimal / (R) Mirror - Scratch, Peeled - Minimal / (R) Front Door, Molding - Scratch - Minimal / (R) Rear Door, Molding - Scratch - Large / (R) Rear Fender, Molding - Scratch - Minimal / Rear Bumper, Lamps, Panels - Scratch - Minimal / (L) Rear Fender, Molding - Scratch - Small / (L) Rear Door, Molding - Scratch - Minimal / (L) Front Door, Molding - Scratch - Small / (L) Front Fender, Molding - Scratch - Small / Bonnet, Headlight - Scratch & Dent - Large / Roof - Scratch - Medium / Member (Bolted) - Dent - Yes</p>
