## General Information

<b>Make</b>	Toyota	<b>Model</b>	Vios
<b>YOM</b>	2025	<b>Odo Meter Reading</b>	11,287
<b>Registration No.</b>	EAJ7295	<b>Chassis No.</b>	PA1B18F34R4280232
<b>CC</b>	1.3	<b>Transmission</b>	CVT
<b>Fuel Type</b>	Gas	<b>Type of Body</b>	Sedan
<b>Colour</b>	Red

## Body / Panel Condition

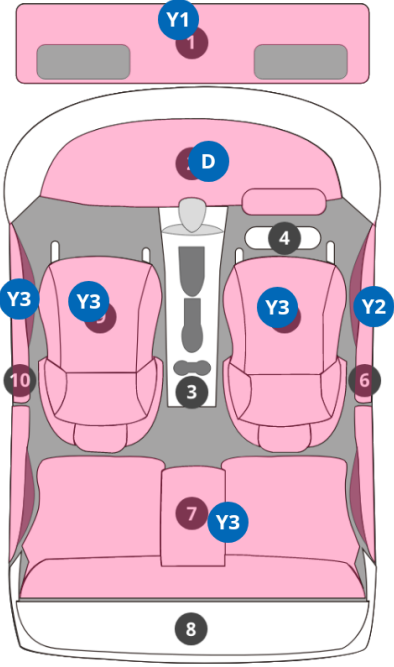
<p><b>a</b> : Cut, Fray <b>d</b> : Loose, Deformed <b>k</b> : Animal Hair <b>s</b> : Smell <b>t</b> : Cigarette Burns <b>x</b> : Defective <b>y</b> : Stain</p>

<p><b>A</b> : Scratch <b>AU</b> : Scratch &amp; Dent <b>B</b> : Modified <b>C</b> : Corrosion <b>G</b> : Stone chip <b>P</b> : Faded <b>S</b> : Rust <b>SC</b> : Rust &amp; Corrosion <b>U</b> : Dent <b>X</b> : Defective <b>Y</b> : Crack, Gap</p>
<p><b>Remarks</b> (R) Front Seat - Grime - Medium / (R) Front Trim - Grime - Small / Rear Seat - Grime - Medium / (L) Front Trim - Grime - Medium / (L) Front Seat - Grime - Medium / Dashboard - Traces of Adhesive Tape - Yes / Ceiling - Grime - Minimal</p>	<p><b>Remarks</b> (R) Front Door, Molding - Scratch - Minimal / (R) Rear Door, Molding - Scratch - Minimal / (R) Rear Fender, Molding - Scratch - Minimal / Trunk Hood, Rear Gate - Scratch - Small / Rear Bumper, Lamps, Panels - Scratch - Small / (L) Rear Fender, Molding - Scratch - Minimal / (L) Rear Door, Molding - Scratch - Minimal / Roof - Scratch &amp; Dent - Small / (R) Front Fender, Molding - Scratch - Minimal / (L) Front Fender, Molding - Scratch - Minimal / (L) Front Door, Molding - Scratch - Medium / Bonnet, Headlight - Scratch - Medium / Front Bumper, Grille, Lamps - Scratch - Medium</p>
