## General Information

<b>Make</b>	Toyota	<b>Model</b>	Hilux
<b>YOM</b>	2024	<b>Odo Meter Reading</b>	72,150
<b>Registration No.</b>	CCA2369	<b>Chassis No.</b>	MR0AB8DD5P5149416
<b>CC</b>	2.4	<b>Transmission</b>	A/T
<b>Fuel Type</b>	Diesel	<b>Type of Body</b>	Pickup
<b>Colour</b>	Red

## Body / Panel Condition

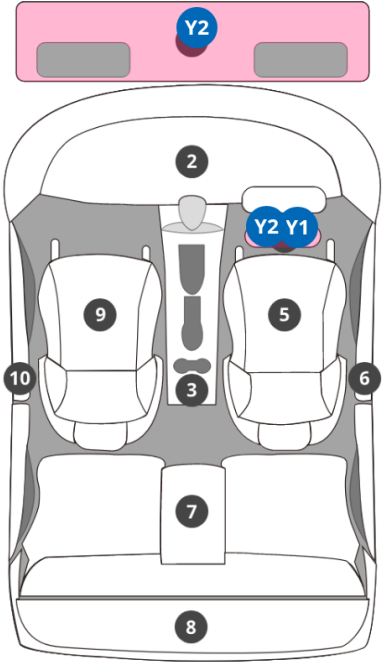
<b>Interior Evaluation :</b> <span style="color: red; font-size: 24px; float: right;">A</span>	<b>Exterior Evaluation :</b> <span style="color: red; font-size: 24px; float: right;">C</span>

<p><b>a</b> : Cut, Fray <b>d</b> : Loose, Deformed <b>k</b> : Animal Hair <b>s</b> : Smell <b>t</b> : Cigarette Burns <b>x</b> : Defective <b>y</b> : Stain</p>

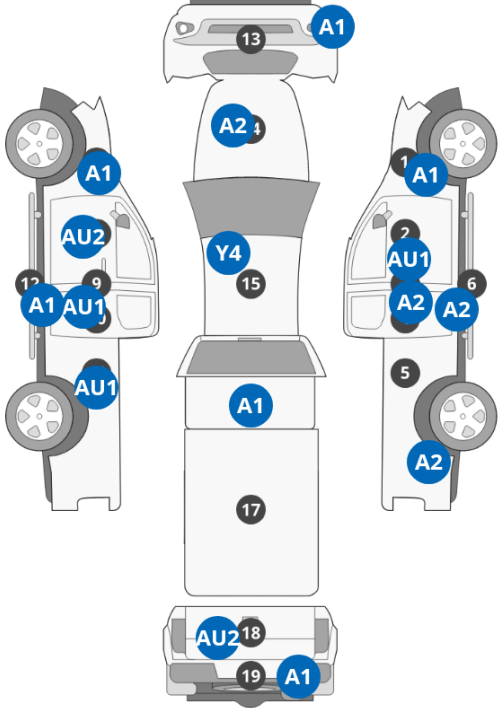
<p><b>A</b> : Scratch <b>AU</b> : Scratch &amp; Dent <b>B</b> : Modified <b>C</b> : Corrosion <b>G</b> : Stone chip <b>P</b> : Faded <b>S</b> : Rust <b>SC</b> : Rust &amp; Corrosion <b>U</b> : Dent <b>X</b> : Defective <b>Y</b> : Crack, Gap</p>
<p><b>Remarks</b> Ceiling - Grime - Small / (R) Front Floor Mat - Grime - Minimal / (L) Front Floor Mat - Grime - Small</p>	<p><b>Remarks</b> Front Windshield - Damaged - Large / (R) Front Fender, Molding - Scratch - Minimal / (R) Front Door, Molding - Scratch &amp; Dent - Minimal / (R) Step, In-panel, Side Spoiler - Scratch - Small / (R) Rear Door, Molding - Scratch - Small / (R) Side Gate - Scratch - Small / Rear Gate - Scratch &amp; Dent - Small / Rear Bumper, Lamps, Panels - Scratch - Minimal / (L) Side Gate - Scratch &amp; Dent - Minimal / (L) Rear Door, Molding - Scratch &amp; Dent - Minimal / (L) Front Door, Molding - Scratch &amp; Dent - Small / (L) Step, In-panel, Side Spoiler - Scratch - Minimal / Roof - Scratch - Minimal / (L) Front Fender, Molding - Scratch - Minimal / Front Bumper, Grille, Lamps - Scratch - Minimal / Bonnet, Headlight - Scratch - Small</p>

<p><b>Inspector Notes</b></p>
<p>With Lto plate, with spare tire, 1key, no warranty booklet, no jack and tools, scratches on headlights, crack taillights</p>
