General Information

Make	Toyota	Model	Innova
YOM	2025	Odo Meter Reading	27,368
Registration No.	NKI3365	Chassis No.	PA2JA8EM90144865
CC	2.8	Transmission	A/T
Fuel Type	Diesel	Type of Body	Wagon
Colour	Blackish Red Mica

Body / Panel Condition

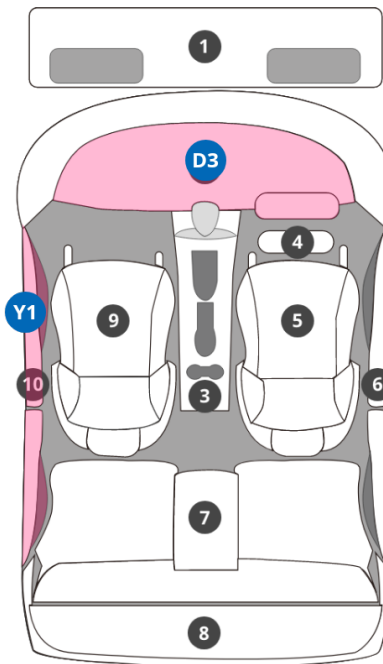
Interior Evaluation : B	Exterior Evaluation : B

<p>a : Cut, Fray d : Loose, Deformed k : Animal Hair s : Smell t : Cigarette Burns x : Defective y : Stain</p>

<p>A : Scratch AU : Scratch & Dent B : Modified C : Corrosion G : Stone chip P : Faded S : Rust SC : Rust & Corrosion U : Dent X : Defective Y : Crack, Gap</p>
<p>Remarks (L) Front Trim - Grime - Minimal / Dashboard - Loose, Deformed - Medium</p>	<p>Remarks (R) Front Fender, Molding - Scratch - Minimal / (R) Mirror - Scratch - Minimal / (R) Front Door, Molding - Scratch - Minimal / (R) Step, In-panel, Side Spoiler - Scratch - Minimal / (R) Rear Door, Molding - Scratch - Small / (R) Rear Fender, Molding - Scratch - Minimal / Roof - Scratch - Minimal / Trunk Hood, Rear Gate - Scratch - Minimal / Rear Bumper, Lamps, Panels - Scratch - Small / (L) Rear Door, Molding - Scratch - Small / (L) Rear Fender, Molding - Scratch - Minimal / (L) Mirror - Scratch - Minimal / (L) Front Door, Molding - Scratch & Dent - Minimal / (L) Front Fender, Molding - Scratch - Minimal / Bonnet, Headlight - Scratch - Minimal / Front Bumper, Grille, Lamps - Scratch - Small</p>

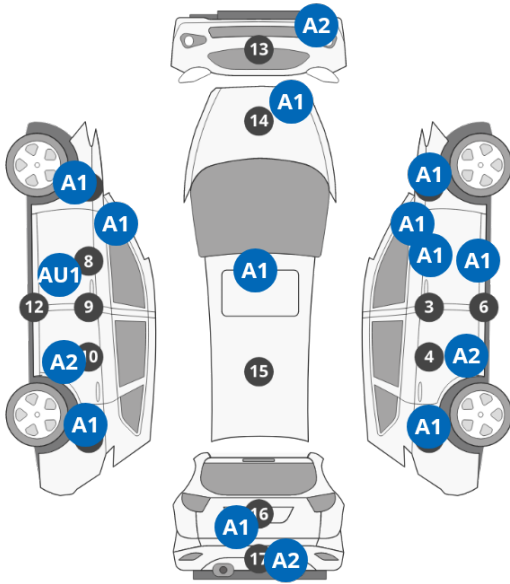
<p>Inspector Notes</p>
<p>With Lto plate, with warranty booklet, with spare tire, 1key, no jack and tools, scratches on headlights and taillights</p>
