## General Information

<b>Make</b>	Toyota	<b>Model</b>	Vios
<b>YOM</b>	2024	<b>Odo Meter Reading</b>	22,220
<b>Registration No.</b>	NIU8158	<b>Chassis No.</b>	PA1B18F35R4244520
<b>CC</b>	1.3	<b>Transmission</b>	CVT
<b>Fuel Type</b>	Gas	<b>Type of Body</b>	Sedan
<b>Colour</b>	Blue

## Body / Panel Condition

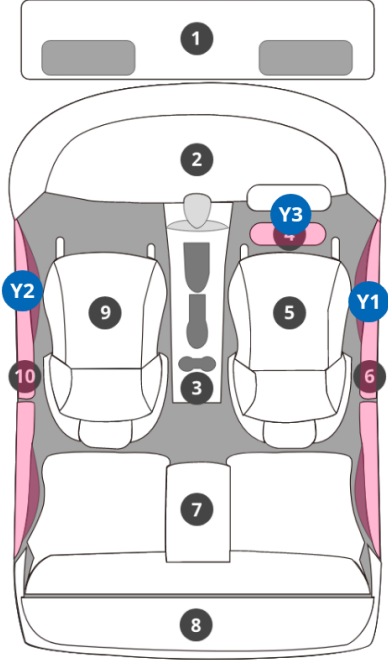
<b>Interior Evaluation :</b> <span style="float: right; color: red; font-weight: bold;">B</span>	<b>Exterior Evaluation :</b> <span style="float: right; color: red; font-weight: bold;">E</span>

<p><b>a</b> : Cut, Fray <b>d</b> : Loose, Deformed <b>k</b> : Animal Hair <b>s</b> : Smell <b>t</b> : Cigarette Burns <b>x</b> : Defective <b>y</b> : Stain</p>

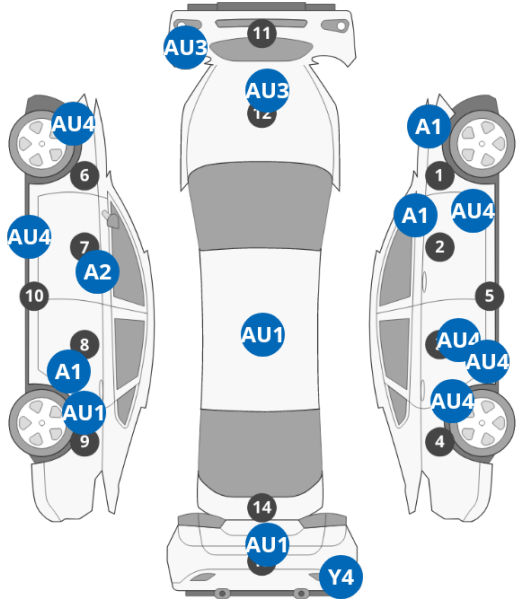
<p><b>A</b> : Scratch <b>AU</b> : Scratch &amp; Dent <b>B</b> : Modified <b>C</b> : Corrosion <b>G</b> : Stone chip <b>P</b> : Faded <b>S</b> : Rust <b>SC</b> : Rust &amp; Corrosion <b>U</b> : Dent <b>X</b> : Defective <b>Y</b> : Crack, Gap</p>
<p><b>Remarks</b>  (L) Front Floor Mat - Grime - Medium / (L) Front Trim - Grime - Small / (R) Front Trim - Grime - Minimal</p>	<p><b>Remarks</b>  (R) Front Fender, Molding - Scratch - Minimal / (R) Mirror - Scratch - Minimal / (R) Front Door, Molding - Scratch &amp; Dent - Large / (R) Rear Door, Molding - Scratch &amp; Dent - Large / (R) Step, In-panel, Side Spoiler - Scratch &amp; Dent - Large / (R) Rear Fender, Molding - Scratch &amp; Dent - Large / Rear Bumper, Lamps, Panels - Crack, Gap - Large / Trunk Hood, Rear Gate - Scratch &amp; Dent - Minimal / (L) Rear Fender, Molding - Scratch &amp; Dent - Minimal / (L) Rear Door, Molding - Scratch - Minimal / (L) Front Door, Molding - Scratch - Small / (L) Step, In-panel, Side Spoiler - Scratch &amp; Dent - Large / (L) Front Fender, Molding - Scratch &amp; Dent - Large / Bonnet, Headlight - Scratch &amp; Dent - Medium / Front Bumper, Grille, Lamps - Scratch &amp; Dent - Medium / Roof - Scratch &amp; Dent - Minimal</p>
