General Information

Make	Toyota	Model	Vios
YOM	2022	Odo Meter Reading	119,043
Registration No.	CBD4991	Chassis No.	PA1B18F37N418168
CC	1.3	Transmission	CVT
Fuel Type	Gas	Type of Body	Sedan
Colour	Blue

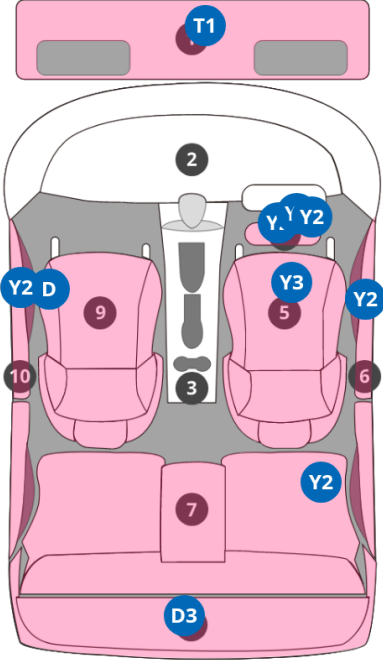
Interior Evaluation : C	Exterior Evaluation : E

<p>a : Cut, Fray d : Loose, Deformed k : Animal Hair s : Smell t : Cigarette Burns x : Defective y : Stain</p>

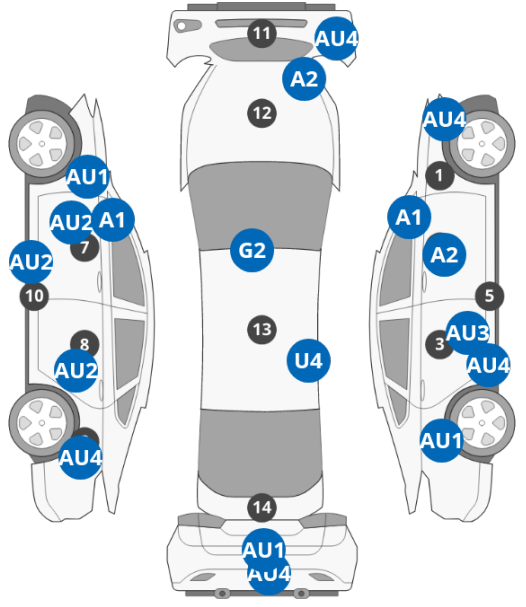
<p>A : Scratch AU : Scratch & Dent B : Modified C : Corrosion G : Stone chip P : Faded S : Rust SC : Rust & Corrosion U : Dent X : Defective Y : Crack, Gap</p>
Remarks Ceiling - Cigarette Burns - Burnt Minimal / Room Mirror - Partially Missing - Yes / (L) Front Floor Mat - Grime - Small / (R) Front Floor Mat - Grime - Large / (R) Front Seat - Grime - Medium / (R) Front Trim - Grime - Small / (L) Front Seat - Worn - Yes / (L) Front Trim - Grime - Small / Mat Other - Grime - Small / Trunk Room - Loose, Deformed - Medium / Rear Seat - Grime - Small / Overall Interior - Worn as per age - Yes	Remarks (R) Front Fender, Molding - Scratch & Dent - Large / (R) Mirror - Scratch - Minimal / (R) Front Door, Molding - Scratch - Small / (R) Step, In-panel, Side Spoiler - Scratch & Dent - Large / (R) Rear Door, Molding - Scratch & Dent - Medium / Roof - Dent - Large / (R) Rear Fender, Molding - Scratch & Dent - Minimal / Rear Bumper, Lamps, Panels - Scratch & Dent - Large / Trunk Hood, Rear Gate - Scratch & Dent - Minimal / (L) Rear Fender, Molding - Scratch & Dent - Large / (L) Rear Door, Molding - Scratch & Dent - Small / (L) Step, In-panel, Side Spoiler - Scratch & Dent - Small / (L) Front Door, Molding - Scratch & Dent - Small / (L) Mirror - Scratch - Minimal / (L) Front Fender, Molding - Scratch & Dent - Minimal / Front Bumper, Grille, Lamps - Scratch & Dent - Large / Bonnet, Headlight - Scratch - Small / Front Windshield - Scratch, Stone chip - Small
