## General Information

| Make | Toyota | Model | Raize |
| YOM | 2023 | Mileage | 19,071 |
| Registration No. | NHJ4149 | Chassis No. | MHKAA1BA4PJ093063 |

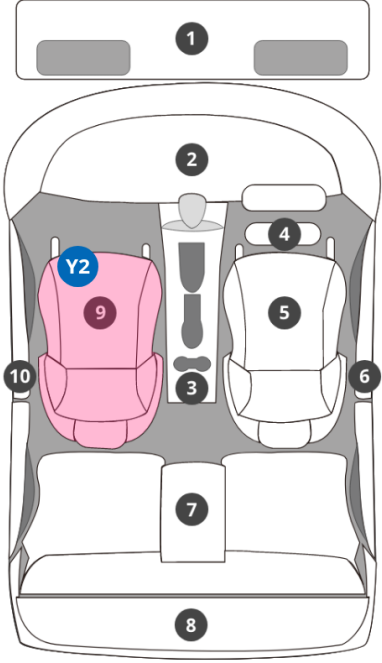
| Interior Evaluation : <span style="color: red;">A</span> | Exterior Evaluation : <span style="color: red;">C</span> |
| <b>Remarks</b><br>(L) Front Seat - Grime - Small | <b>Remarks</b><br>(R) Front Door - Repair Traces - Yes / (R) Front Fender - Repair Traces - Yes / (L) Front Fender - Repair Traces - Yes / Roof - Repair Traces - Yes / Front Bumper, Grille, Lamps - Scratch & Dent - Large / (L) Front Fender, Molding - Scratch & Dent - Medium / (R) Step, In-panel, Side Spoiler - Scratch - Medium / (R) Front Door, Molding - Scratch - Small / (R) Rear Door, Molding - Scratch - Medium / Rear Bumper, Lamps, Panels - Scratch & Dent - Large / (L) Front Door, Molding - Scratch - Small |
