General Information

Make	Toyota	Model	Vios
YOM	2024	Odo Meter Reading	45,283
Registration No.	NFR8616	Chassis No.	PA1B18F37R4260184
CC	1.3	Transmission	CVT
Fuel Type	Gas	Type of Body	Sedan
Colour	Silver

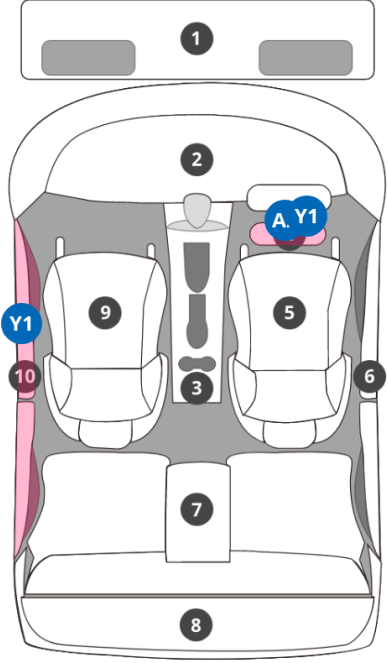
Interior Evaluation : A	Exterior Evaluation : D

<p>a : Cut, Fray d : Loose, Deformed k : Animal Hair s : Smell t : Cigarette Burns x : Defective y : Stain</p>

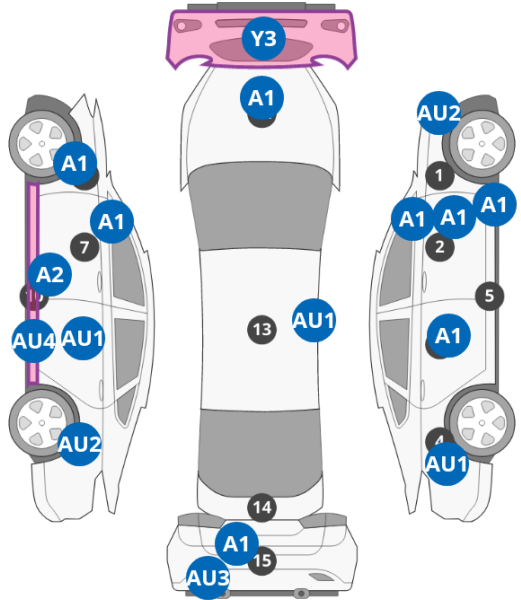
<p>A : Scratch AU : Scratch & Dent B : Modified C : Corrosion G : Stone chip P : Faded S : Rust SC : Rust & Corrosion U : Dent X : Defective Y : Crack, Gap</p>
<p>Remarks (L) Front Trim - Grime - Minimal / (L) Front Floor Mat - Cut, Crack - Small / (R) Front Floor Mat - Grime - Minimal</p>	<p>Remarks (L) Step - Repair Traces - Yes / (R) Front Fender, Molding - Scratch & Dent - Small / (R) Mirror - Scratch - Minimal / (R) Front Door, Molding - Scratch - Minimal / (R) Step, In-panel, Side Spoiler - Scratch - Minimal / Roof - Scratch & Dent - Minimal / (R) Rear Door, Molding - Scratch - Minimal / (R) Rear Fender, Molding - Scratch & Dent - Minimal / Trunk Hood, Rear Gate - Scratch - Minimal / Rear Bumper, Lamps, Panels - Scratch & Dent - Medium / (L) Rear Fender, Molding - Scratch & Dent - Small / (L) Rear Door, Molding - Scratch & Dent - Minimal / (L) Step, In-panel, Side Spoiler - Repair mark - Difference in Color / (L) Front Door, Molding - Scratch - Small / (L) Step, In-panel, Side Spoiler - Scratch & Dent - Large / (L) Mirror - Scratch - Minimal / (L) Front Fender, Molding - Scratch - Minimal / Front Bumper, Grille, Lamps - Repair mark - Yes / Front Bumper, Grille, Lamps - Crack, Gap - Medium / Bonnet, Headlight - Scratch - Minimal</p>
