General Information

Make	Toyota	Model	Vios
YOM	2025	Odo Meter Reading	53,223
Registration No.	NHS8801	Chassis No.	PA1B18F38R4268763
CC	1.3	Transmission	CVT
Fuel Type	Gas	Type of Body	Sedan
Colour	Red

Body / Panel Condition

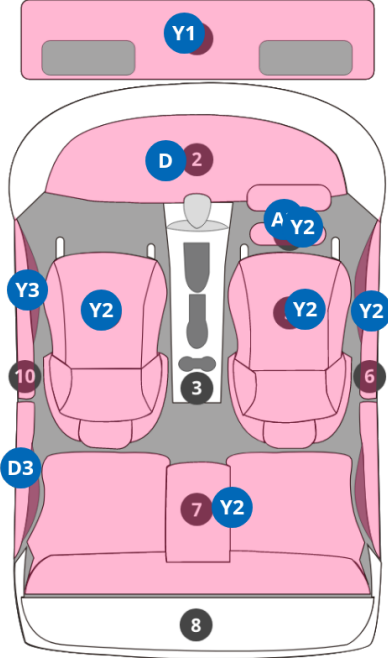
Interior Evaluation : C	Exterior Evaluation : D

<p>a : Cut, Fray d : Loose, Deformed k : Animal Hair s : Smell t : Cigarette Burns x : Defective y : Stain</p>

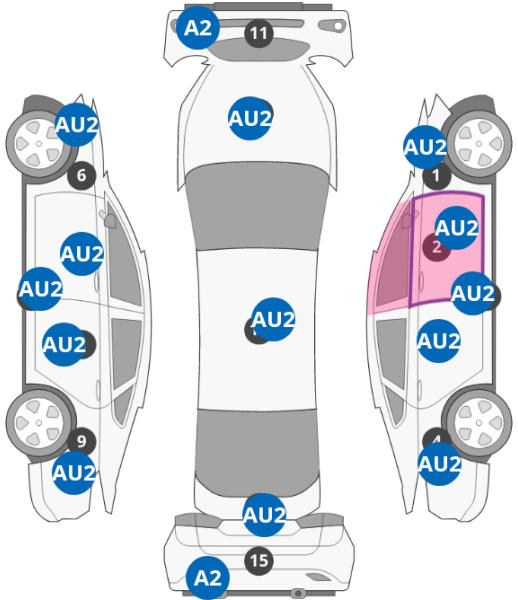
<p>A : Scratch AU : Scratch & Dent B : Modified C : Corrosion G : Stone chip P : Faded S : Rust SC : Rust & Corrosion U : Dent X : Defective Y : Crack, Gap</p>
<p>Remarks (L) Front Seat - Grime - Small / (R) Front Seat - Grime - Small / Rear Seat - Grime - Small / (L) Front Trim - Grime - Medium / (L) Rear Trim - Loose, Deformed - Medium / (R) Front Trim - Grime - Small / Dashboard - Traces of Adhesive Tape - Yes / Ceiling - Grime - Minimal / (L) Front Floor Mat - Cut, Crack - Medium / (R) Front Floor Mat - Grime - Small</p>	<p>Remarks (R) Front Fender - Repair Traces - Yes / Roof - Scratch & Dent - Small / (L) Rear Door, Molding - Scratch & Dent - Small / (L) Front Door, Molding - Scratch & Dent - Small / (L) Step, In-panel, Side Spoiler - Scratch & Dent - Small / (L) Front Fender, Molding - Scratch & Dent - Small / Bonnet, Headlight - Scratch & Dent - Small / (R) Front Fender, Molding - Scratch & Dent - Small / (R) Front Door, Molding - Scratch & Dent - Small / (R) Rear Door, Molding - Scratch & Dent - Small / (R) Front Door, Molding - Repair mark - Yes / (R) Rear Fender, Molding - Scratch & Dent - Small / Trunk Hood, Rear Gate - Scratch & Dent - Small / Rear Bumper, Lamps, Panels - Scratch - Small / (R) Step, In-panel, Side Spoiler - Scratch & Dent - Small / Front Bumper, Grille, Lamps - Scratch - Small / (L) Rear Fender, Molding - Scratch & Dent - Small</p>
