General Information

Make	Toyota	Model	Vios
YOM	2024	Odo Meter Reading	29,614
Registration No.	DBO6855	Chassis No.	PA1B18F31R4253781
CC	1.3	Transmission	CVT
Fuel Type	Gas	Type of Body	Sedan
Colour	Blackish Red Mica

Body / Panel Condition

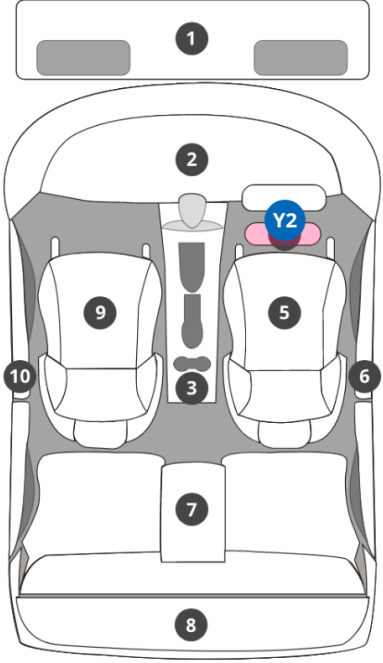
Interior Evaluation : A	Exterior Evaluation : D

<p>a : Cut, Fray d : Loose, Deformed k : Animal Hair s : Smell t : Cigarette Burns x : Defective y : Stain</p>

<p>A : Scratch AU : Scratch & Dent B : Modified C : Corrosion G : Stone chip P : Faded S : Rust SC : Rust & Corrosion U : Dent X : Defective Y : Crack, Gap</p>
Remarks (L) Front Floor Mat - Grime - Small	Remarks (R) Front Fender, Molding - Scratch - Small / (R) Mirror - Scratch - Minimal / (R) Front Door, Molding - Scratch & Dent - Medium / (R) Step, In-panel, Side Spoiler - Scratch - Minimal / (R) Rear Door, Molding - Scratch & Dent - Large / (R) Rear Fender, Molding - Scratch & Dent - Medium / Rear Bumper, Lamps, Panels - Crack, Gap - Medium / Trunk Hood, Rear Gate - Scratch - Minimal / (L) Rear Fender, Molding - Scratch & Dent - Minimal / (L) Rear Door, Molding - Scratch - Minimal / (L) Mirror - Scratch - Minimal / (L) Front Door, Molding - Scratch & Dent - Minimal / (L) Front Fender, Molding - Scratch - Minimal / Front Bumper, Grille, Lamps - Modified - Medium / Bonnet, Headlight - Crack, Gap - Medium

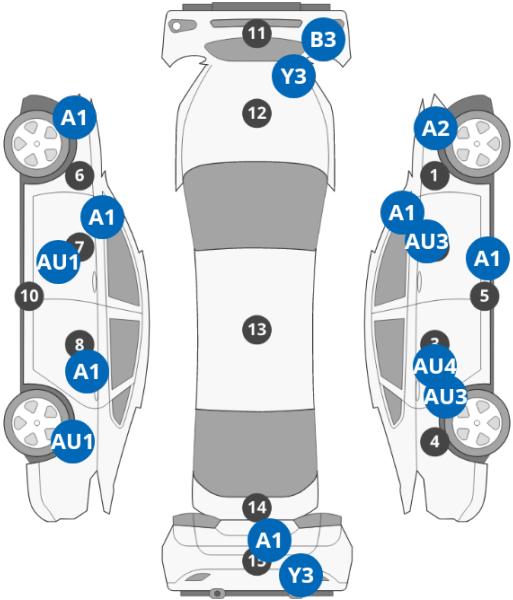
Inspector Notes
With Lto plate, with warranty booklet and jack, 3keys, no spare tire and tools, Crack headlight, scratches on taillights, battery weak
