## General Information

| Make | Toyota | Model | Vios |

## Body / Panel Condition

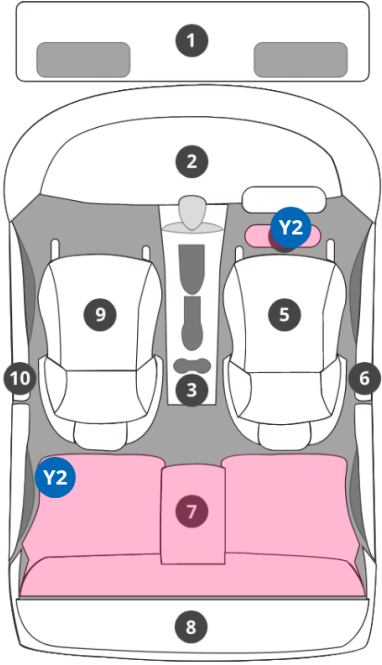
| Interior Evaluation : <span style="color: red;">A</span> | Exterior Evaluation : <span style="color: red;">B</span> |
|---|---|
| <b>Remarks</b><br>Rear Seat - Grime - Small / (L) Front Floor Mat - Grime - Small | <b>Remarks</b><br>(L) Front Fender - Repair Traces - Yes / Front Bumper, Grille, Lamps - Scratch - Medium / (R) Rear Fender, Molding - Dent - Small / (R) Rear Door, Molding - Dent - Minimal / Roof - Dent - Small / Trunk Hood, Rear Gate - Scratch - Medium |
