## General Information

<b>Make</b>	Toyota	<b>Model</b>	Vios
<b>YOM</b>	2021	<b>Odo Meter Reading</b>	158,814
<b>Registration No.</b>	ZAC1070	<b>Chassis No.</b>	PA1B18F31M4163443
<b>CC</b>	1.3	<b>Transmission</b>	M/T
<b>Fuel Type</b>	Gas	<b>Type of Body</b>	Sedan
<b>Colour</b>	Green

## Body / Panel Condition

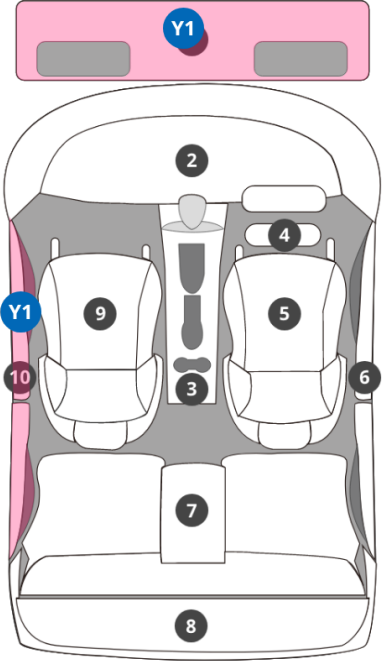
<b>Interior Evaluation :</b> <span style="float: right; color: red; font-weight: bold;">A</span>	<b>Exterior Evaluation :</b> <span style="float: right; color: red; font-weight: bold;">E</span>

<p><b>a</b> : Cut, Fray <b>d</b> : Loose, Deformed <b>k</b> : Animal Hair <b>s</b> : Smell <b>t</b> : Cigarette Burns <b>x</b> : Defective <b>y</b> : Stain</p>

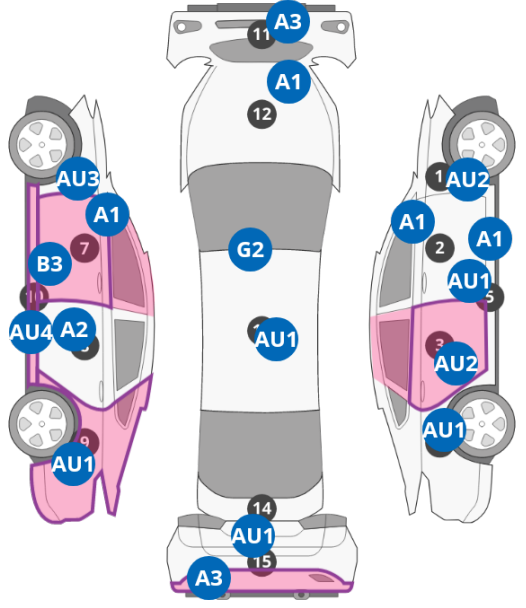
<p><b>A</b> : Scratch <b>AU</b> : Scratch &amp; Dent <b>B</b> : Modified <b>C</b> : Corrosion <b>G</b> : Stone chip <b>P</b> : Faded <b>S</b> : Rust <b>SC</b> : Rust &amp; Corrosion <b>U</b> : Dent <b>X</b> : Defective <b>Y</b> : Crack, Gap</p>
<p><b>Remarks</b> Ceiling - Grime - Minimal / (L) Front Trim - Grime - Minimal</p>	<p><b>Remarks</b> (R) Front Fender - Repair Traces - Yes / (L) Front Fender - Repair Traces - Yes / (L) Front Door - Repair Traces - Yes / (L) Step - Repair Traces - Yes / (L) Rear Door - Repair Traces - Yes / (L) Rear Fender - Repair Traces - Yes / Roof - Repair Traces - Yes / (R) Front Fender, Molding - Scratch &amp; Dent - Small / (R) Mirror - Scratch - Minimal / Overall Exterior - Full Re-Paint in same color - Yes / (R) Front Door, Molding - Scratch &amp; Dent - Minimal / (R) Rear Door, Molding - Repair mark - Yes / (R) Rear Door, Molding - Scratch &amp; Dent - Small / (R) Step, In-panel, Side Spoiler - Scratch - Minimal / Roof - Scratch &amp; Dent - Minimal / (R) Rear Fender, Molding - Scratch &amp; Dent - Minimal / Rear Bumper, Lamps, Panels - Repair mark - Difference in Color / Rear Bumper, Lamps, Panels - Scratch - Medium / Trunk Hood, Rear Gate - Scratch &amp; Dent - Minimal / (L) Rear Fender, Molding - Scratch &amp; Dent - Minimal / (L) Rear Fender, Molding - Repair mark - Yes / (L) Step, In-panel, Side Spoiler - Repair mark - Yes / (L) Rear Door, Molding - Scratch - Small / (L) Front Door, Molding - Repair mark - Yes / (L) Front Door, Molding - Modified - Medium / (L) Step, In-panel, Side Spoiler - Scratch &amp; Dent - Large / (L) Mirror - Scratch - Minimal / (L) Front Fender, Molding - Scratch &amp; Dent - Medium / Front Bumper, Grille, Lamps - Scratch - Medium / Bonnet, Headlight - Scratch - Minimal / Front Windshield - Scratch, Stone chip - Small</p>
