General Information

Make	Toyota	Model	Vios
YOM	2024	Odo Meter Reading	33,763
Registration No.	NHQ5647	Chassis No.	PA1B18F30R4244618
CC	1.3	Transmission	CVT
Fuel Type	Gas	Type of Body	Sedan
Colour	Red Mica Metallic

Body / Panel Condition

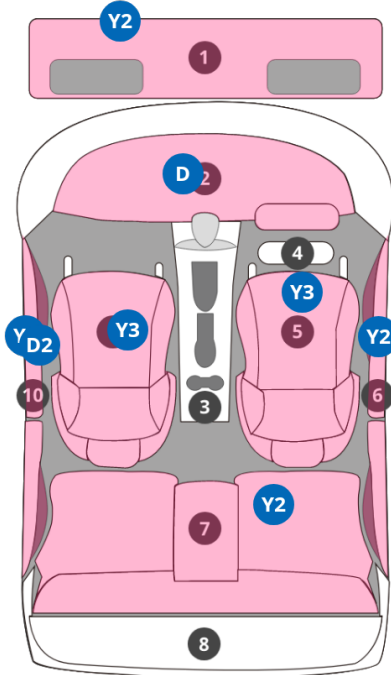
Interior Evaluation : B	Exterior Evaluation : C

<p>A : Scratch AU : Scratch & Dent B : Modified C : Corrosion G : Stone chip P : Faded S : Rust SC : Rust & Corrosion U : Dent X : Defective Y : Crack, Gap</p>
<p>Remarks (R) Front Seat - Grime - Medium / (L) Front Seat - Grime - Medium / Rear Seat - Grime - Small / (R) Front Trim - Grime - Small / (L) Front Trim - Grime - Small / Ceiling - Grime - Small / Dashboard - Traces of Adhesive Tape - Yes</p>	<p>Remarks (R) Front Fender, Molding - Scratch - Small / (R) Mirror - Scratch - Minimal / (R) Step, In-panel, Side Spoiler - Scratch - Small / (R) Front Door, Molding - Scratch - Minimal / (R) Rear Door, Molding - Scratch - Small / (R) Rear Fender, Molding - Scratch - Minimal / Rear Bumper, Lamps, Panels - Scratch - Minimal / Trunk Hood, Rear Gate - Scratch - Minimal / (L) Rear Fender, Molding - Scratch - Small / (L) Front Door, Molding - Scratch - Minimal / (L) Rear Door, Molding - Scratch - Minimal / (L) Mirror - Scratch - Small / (L) Front Fender, Molding - Scratch - Small / Front Bumper, Grille, Lamps - Scratch - Medium / Bonnet, Headlight - Scratch - Small / Roof - Scratch - Minimal</p>

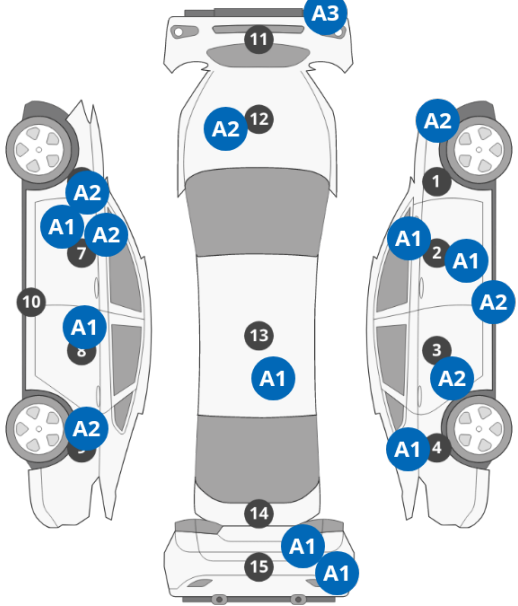
<p>Inspector Notes</p>
<p>no warranty booklet, jack and tools, with spare tire, with LTO plate, scratches on tail light</p>
