## General Information

<b>Make</b>	Toyota	<b>Model</b>	Vios
<b>YOM</b>	2025	<b>Odo Meter Reading</b>	11,645
<b>Registration No.</b>	NKL3468	<b>Chassis No.</b>	PA1B18F3XR4280994
<b>CC</b>	1.3	<b>Transmission</b>	CVT
<b>Fuel Type</b>	Gas	<b>Type of Body</b>	Sedan
<b>Colour</b>	Silver

## Body / Panel Condition

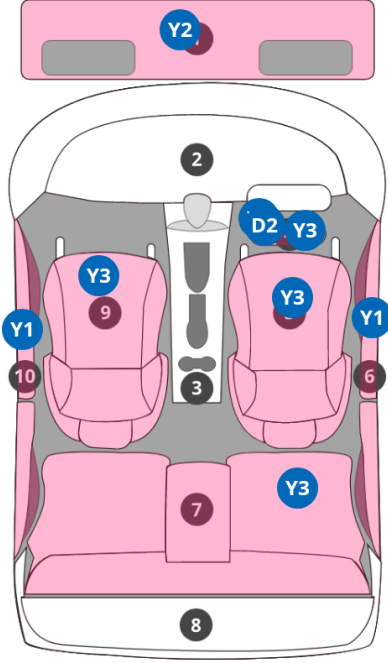
<b>Interior Evaluation :</b> <span style="float: right; color: red; font-weight: bold;">C</span>	<b>Exterior Evaluation :</b> <span style="float: right; color: red; font-weight: bold;">E</span>

<p><b>a</b> : Cut, Fray <b>d</b> : Loose, Deformed <b>k</b> : Animal Hair <b>s</b> : Smell <b>t</b> : Cigarette Burns <b>x</b> : Defective <b>y</b> : Stain</p>

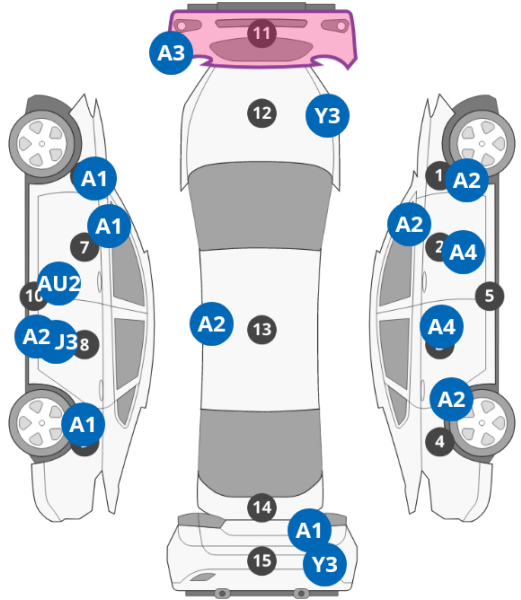
<p><b>A</b> : Scratch <b>AU</b> : Scratch &amp; Dent <b>B</b> : Modified <b>C</b> : Corrosion <b>G</b> : Stone chip <b>P</b> : Faded <b>S</b> : Rust <b>SC</b> : Rust &amp; Corrosion <b>U</b> : Dent <b>X</b> : Defective <b>Y</b> : Crack, Gap</p>
<p><b>Remarks</b> Rear Seat - Grime - Medium / (R) Front Seat - Grime - Medium / (L) Front Seat - Grime - Medium / (R) Front Floor Mat - Grime - Medium / (R) Front Trim - Grime - Minimal / (L) Front Trim - Grime - Minimal / (L) Front Floor Mat - Grime - Medium / Ceiling - Grime - Small / (L) Front Floor Mat - Worked - Small</p>	<p><b>Remarks</b> (L) Rear Fender - Repair Traces - Yes / (R) Mirror - Scratch - Small / (R) Front Door, Molding - Scratch - Large / (R) Front Fender, Molding - Scratch - Small / (R) Rear Door, Molding - Scratch - Large / (R) Rear Fender, Molding - Scratch - Small / Rear Bumper, Lamps, Panels - Crack, Gap - Medium / Trunk Hood, Rear Gate - Scratch - Minimal / (L) Rear Fender, Molding - Scratch - Minimal / (L) Rear Door, Molding - Scratch &amp; Dent - Medium / (L) Front Door, Molding - Scratch &amp; Dent - Small / (L) Step, In-panel, Side Spoiler - Scratch - Small / (L) Mirror - Scratch - Minimal / (L) Front Fender, Molding - Scratch - Minimal / Front Bumper, Grille, Lamps - Repair mark - Yes / Front Bumper, Grille, Lamps - Scratch - Medium / Bonnet, Headlight - Crack, Gap - Medium / Roof - Scratch - Small</p>

<p><b>Inspector Notes</b></p>
<p>no warranty booklet, with jack, incomplete tools, with spare tire, with LTO plate, scratched and cracked tail light, power steering issue due to weak battery</p>
