General Information

Make	Toyota	Model	Vios
YOM	2025	Odo Meter Reading	58,488
Registration No.	NEY8950	Chassis No.	PA1B18F33R4264281
CC	1.3	Transmission	CVT
Fuel Type	Gas	Type of Body	Sedan
Colour	Blue

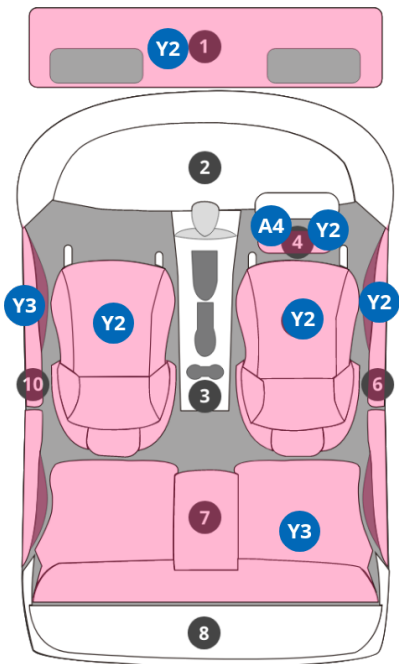
Interior Evaluation : C	Exterior Evaluation : E

<p>a : Cut, Fray d : Loose, Deformed k : Animal Hair s : Smell t : Cigarette Burns x : Defective y : Stain</p>

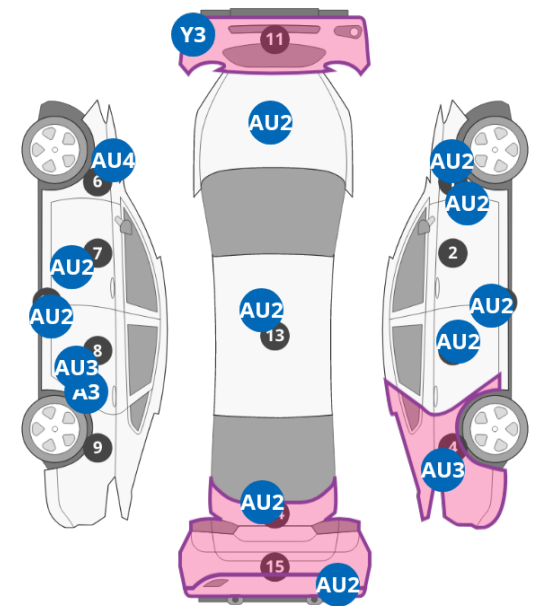
<p>A : Scratch AU : Scratch & Dent B : Modified C : Corrosion G : Stone chip P : Faded S : Rust SC : Rust & Corrosion U : Dent X : Defective Y : Crack, Gap</p>
<p>Remarks (L) Front Floor Mat - Cut, Crack - Large / (R) Front Floor Mat - Grime - Small / (L) Front Seat - Grime - Small / (R) Front Seat - Grime - Small / (L) Front Trim - Grime - Medium / (R) Front Trim - Grime - Small / Ceiling - Grime - Small / Rear Seat - Grime - Medium</p>	<p>Remarks (R) Front Fender - Repair Traces - Yes / Bonnet - Repair Traces - Yes / (L) Front Fender - Repair Traces - Yes / Trunk Hood, Rear Gate - Repair Traces - Yes / Roof - Scratch & Dent - Small / (L) Rear Fender, Molding - Scratch - Medium / (L) Front Door, Molding - Scratch & Dent - Small / (L) Front Fender, Molding - Scratch & Dent - Large / Front Bumper, Grille, Lamps - Repair mark - Yes / Front Bumper, Grille, Lamps - Crack, Gap - Medium / Bonnet, Headlight - Scratch & Dent - Small / (R) Front Fender, Molding - Scratch & Dent - Small / (R) Front Door, Molding - Scratch & Dent - Small / (R) Rear Door, Molding - Scratch & Dent - Small / (R) Step, In-panel, Side Spoiler - Scratch & Dent - Small / (R) Rear Fender, Molding - Repair mark - Yes / (R) Rear Fender, Molding - Scratch & Dent - Medium / Trunk Hood, Rear Gate - Repair mark - Yes / Rear Bumper, Lamps, Panels - Repair mark - Yes / Trunk Hood, Rear Gate - Scratch & Dent - Small / Rear Bumper, Lamps, Panels - Scratch & Dent - Small / (L) Rear Door, Molding - Scratch & Dent - Medium / (L) Step, In-panel, Side Spoiler - Scratch & Dent - Small</p>
