General Information

Make	Toyota	Model	Vios
YOM	2025	Odo Meter Reading	38,347
Registration No.	NGC9885	Chassis No.	PA1B18F33R4274177
CC	1.3	Transmission	CVT
Fuel Type	Gas	Type of Body	Sedan
Colour	Black

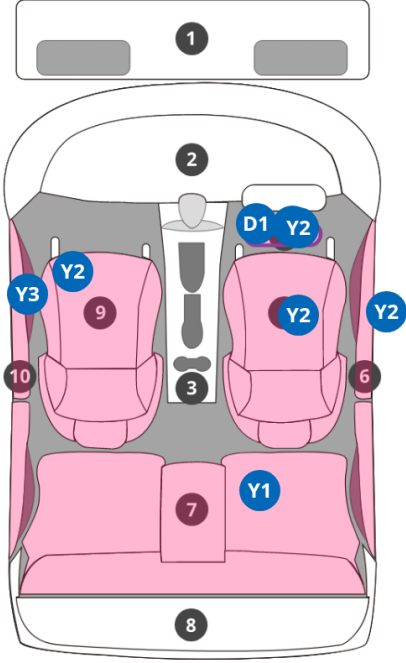
Interior Evaluation : B	Exterior Evaluation : E

<p>a : Cut, Fray d : Loose, Deformed k : Animal Hair s : Smell t : Cigarette Burns x : Defective y : Stain</p>

<p>A : Scratch AU : Scratch & Dent B : Modified C : Corrosion G : Stone chip P : Faded S : Rust SC : Rust & Corrosion U : Dent X : Defective Y : Crack, Gap</p>
<p>Remarks (L) Front Floor Mat - Missing - Yes / (R) Front Floor Mat - Grime - Small / (L) Front Seat - Grime - Small / (R) Front Seat - Grime - Small / (L) Front Trim - Grime - Medium / (R) Front Trim - Grime - Small / Rear Seat - Grime - Minimal / Carpet - Worked - Minimal</p>	<p>Remarks (L) Rear Door, Molding - Dent - Medium / (L) Step, In-panel, Side Spoiler - Scratch & Dent - Small / (L) Front Door, Molding - Scratch & Dent - Medium / (L) Front Fender, Molding - Scratch & Dent - Small / Bonnet, Headlight - Scratch - Medium / Front Bumper, Grille, Lamps - Scratch - Medium / (R) Front Fender, Molding - Scratch & Dent - Small / (R) Front Door, Molding - Scratch & Dent - Small / (R) Rear Door, Molding - Scratch & Dent - Small / Roof - Scratch & Dent - Small / (R) Rear Fender, Molding - Scratch - Medium / (R) Step, In-panel, Side Spoiler - Scratch & Dent - Small / Trunk Hood, Rear Gate - Scratch - Medium / Rear Bumper, Lamps, Panels - Scratch - Medium / (L) Rear Fender, Molding - Scratch & Dent - Small</p>

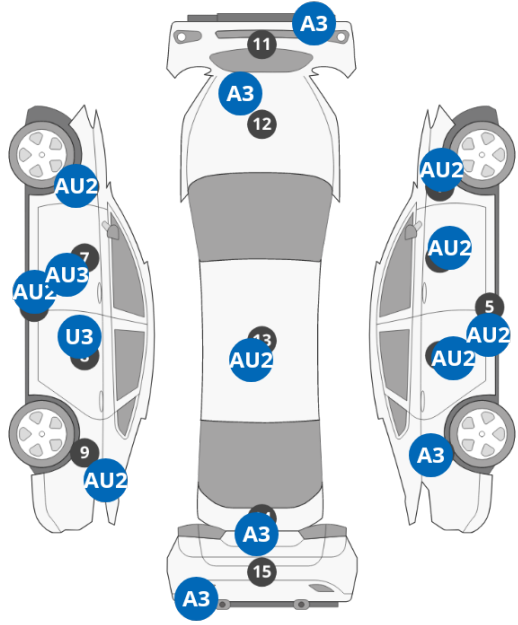
<p>Inspector Notes</p>
<p>with LTO plate, with spare mags, with reverse camera, with spare key, no warranty and manual booklet, scratches on taillight and headlight, issue on headlight.</p>
