General Information

Make	Toyota	Model	Vios
YOM	2023	Odo Meter Reading	163,611
Registration No.	NHI7765	Chassis No.	PA1B18F30P4211020
CC	1.3	Transmission	CVT
Fuel Type	Gas	Type of Body	Sedan
Colour	Silver

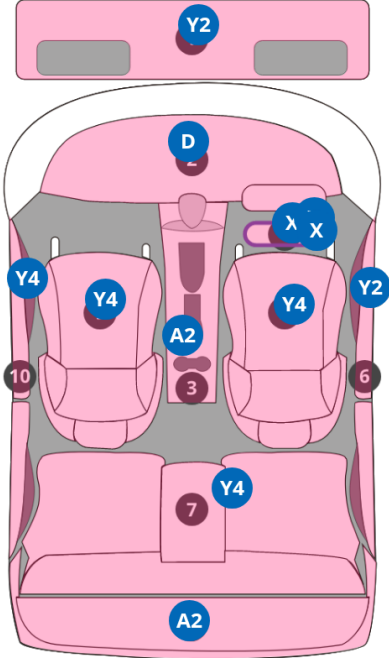
Interior Evaluation : D	Exterior Evaluation : E

<p>a : Cut, Fray d : Loose, Deformed k : Animal Hair s : Smell t : Cigarette Burns x : Defective y : Stain</p>

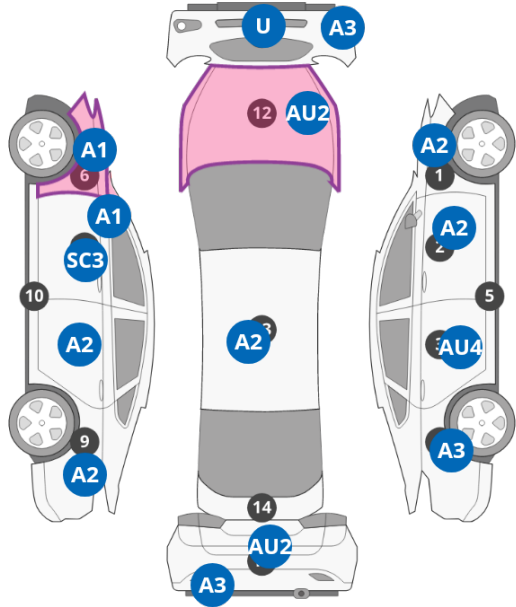
<p>A : Scratch AU : Scratch & Dent B : Modified C : Corrosion G : Stone chip P : Faded S : Rust SC : Rust & Corrosion U : Dent X : Defective Y : Crack, Gap</p>
<p>Remarks Rear Seat - Grime - Large / (R) Front Seat - Grime - Large / (R) Front Trim - Grime - Small / (L) Front Trim - Grime - Large / (L) Front Seat - Grime - Large / (R) Front Floor Mat - Missing - Yes / (L) Front Floor Mat - Missing - Yes / Mat Other - Missing - Yes / Dashboard - Traces of Adhesive Tape - Yes / Trunk Room - Worn, Scratch, Cut, Crack - Small / Ceiling - Grime - Small / Console, Switches, Vents - Worn, Scratch, Cut, Crack - Small</p>	<p>Remarks Bonnet, Headlight - Scratch & Dent - Small / Roof - Scratch - Small / (L) Rear Fender, Molding - Scratch - Small / Rear Bumper, Lamps, Panels - Scratch - Medium / Trunk Hood, Rear Gate - Scratch & Dent - Small / (R) Rear Fender, Molding - Scratch - Medium / (R) Rear Door, Molding - Scratch & Dent - Large / (R) Front Door, Molding - Scratch - Small / (R) Front Fender, Molding - Scratch - Small / Front Bumper, Grille, Lamps - Scratch - Medium / (L) Front Fender, Molding - Repair mark - Yes / (L) Front Fender, Molding - Scratch - Minimal / Bonnet, Headlight - Repair mark - Yes / (L) Mirror - Scratch - Minimal / (L) Rear Door, Molding - Scratch - Small / (L) Front Door, Molding - Rust, Corrosion - Medium / Member (Bolted) - Dent - Yes</p>
