General Information

Make	Toyota	Model	Vios
YOM	2019	Odo Meter Reading	138,144
Registration No.	DAO3112	Chassis No.	PA1B13F31K4082605
CC	1.3	Transmission	A/T
Fuel Type	Gas	Type of Body	Sedan
Colour	Silver

Body / Panel Condition

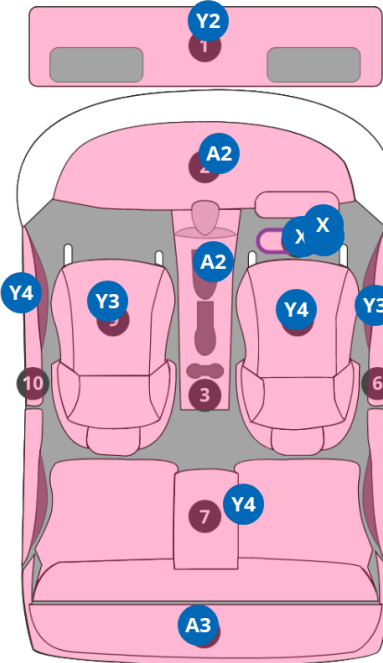
Interior Evaluation : D	Exterior Evaluation : E

<p>a : Cut, Fray d : Loose, Deformed k : Animal Hair s : Smell t : Cigarette Burns x : Defective y : Stain</p>

<p>A : Scratch AU : Scratch & Dent B : Modified C : Corrosion G : Stone chip P : Faded S : Rust SC : Rust & Corrosion U : Dent X : Defective Y : Crack, Gap</p>
Remarks (R) Front Seat - Grime - Large / (R) Front Trim - Grime - Medium / Rear Seat - Grime - Large / Trunk Room - Worn, Scratch, Cut, Crack - Medium / (L) Front Trim - Grime - Large / (L) Front Seat - Grime - Medium / (R) Front Floor Mat - Missing - Yes / (L) Front Floor Mat - Missing - Yes / Mat Other - Missing - Yes / Console, Switchs, Vents - Worn, Scratch, Cut, Crack - Small / Ceiling - Grime - Small / Dashboard - Worn, Scratch, Cut, Crack - Small	Remarks (R) Front Fender - Repair Traces - Yes / Bonnet - Repair Traces - Yes / (L) Front Fender - Repair Traces - Yes / (R) Rear Fender - Repair Traces - Yes / (R) Rear Door - Repair Traces - Yes / Roof - Repair Traces - Yes / (L) Rear Door, Molding - Scratch - Medium / (L) Step, In-panel, Side Spoiler - Scratch - Medium / (L) Front Door, Molding - Scratch - Large / (L) Front Fender, Molding - Scratch - Large / Front Bumper, Grille, Lamps - Scratch - Large / Bonnet, Headlight - Scratch - Medium / (R) Front Fender, Molding - Scratch - Medium / (R) Mirror - Scratch - Medium / (R) Front Door, Molding - Scratch - Medium / (R) Rear Door, Molding - Scratch - Large / (R) Step, In-panel, Side Spoiler - Scratch - Large / (R) Rear Fender, Molding - Scratch - Large / Rear Bumper, Lamps, Panels - Scratch - Medium / Trunk Hood, Rear Gate - Scratch - Small / Roof - Dent - Medium / Member (Bolted) - Rust, Corrosion - Yes
