General Information

Make	Toyota	Model	Yaris Cross
YOM	2024	Odo Meter Reading	15,644
Registration No.	NNV9637	Chassis No.	MHFAB8BF9P0012855
CC	1.5	Transmission	CVT
Fuel Type	Hybrid	Type of Body	SUV
Colour	White

Body / Panel Condition

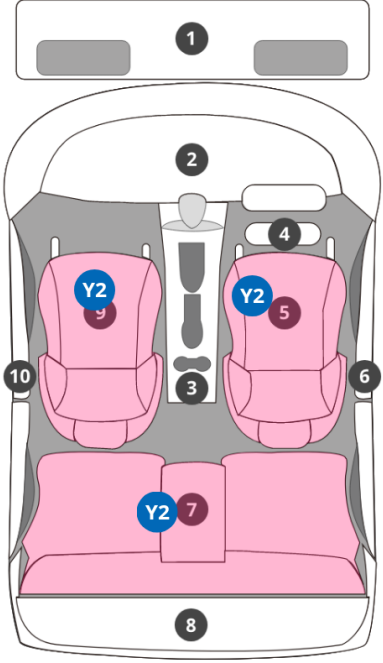
Interior Evaluation : A	Exterior Evaluation : C

<p>a : Cut, Fray d : Loose, Deformed k : Animal Hair s : Smell t : Cigarette Burns x : Defective y : Stain</p>

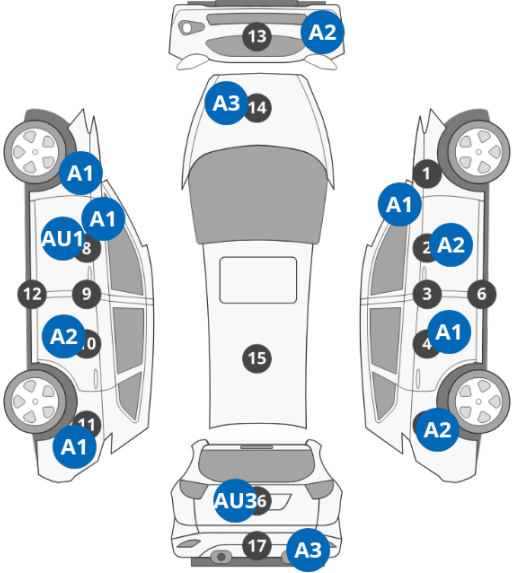
<p>A : Scratch AU : Scratch & Dent B : Modified C : Corrosion G : Stone chip P : Faded S : Rust SC : Rust & Corrosion U : Dent X : Defective Y : Crack, Gap</p>
<p>Remarks (R) Front Seat - Grime - Small / Rear Seat - Grime - Small / (L) Front Seat - Grime - Small</p>	<p>Remarks (L) Front Door - Repair Traces - Yes / (L) Rear Door - Repair Traces - Yes / Roof - Repair Traces - Yes / (L) Front Fender, Molding - Scratch - Minimal / (L) Mirror - Scratch - Minimal / Bonnet, Headlight - Scratch - Medium / Front Bumper, Grille, Lamps - Scratch - Small / (R) Mirror - Scratch - Minimal / (R) Front Door, Molding - Scratch - Small / (R) Rear Fender, Molding - Scratch - Small / (R) Rear Door, Molding - Scratch - Minimal / Rear Bumper, Lamps, Panels - Scratch - Medium / Trunk Hood, Rear Gate - Scratch & Dent - Medium / (L) Rear Fender, Molding - Scratch - Minimal / (L) Rear Door, Molding - Scratch - Small / (L) Front Door, Molding - Scratch & Dent - Minimal</p>
