## General Information

| Make | Toyota | Model | Vios |
| YOM | 2023 | Mileage | 36,958 |

## Body / Panel Condition

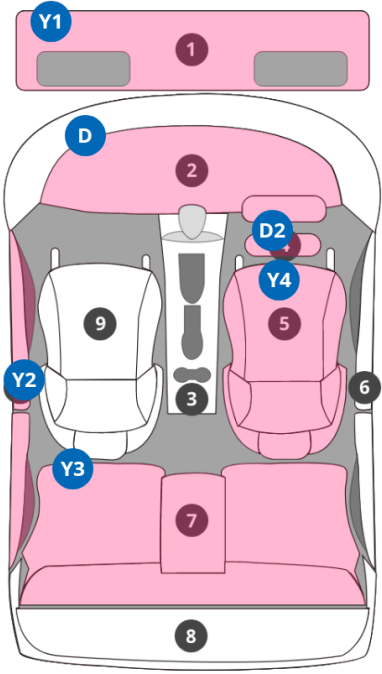
| Interior Evaluation : <span style="color: red;">C</span> | Exterior Evaluation : <span style="color: red;">E</span> |
| <p><b>Remarks</b></p> <p>Rear Seat - Grime - Medium / (R) Front Seat - Grime - Large / (L) Front Floor Mat - Worked - Small / (L) Front Trim - Grime - Small / Ceiling - Grime - Minimal / Dashboard - Traces of Adhesive Tape - Yes</p> | <p><b>Remarks</b></p> <p>(R) Front Door, Molding - Scratch &amp; Dent - Large / (R) Rear Fender, Molding - Scratch &amp; Dent - Large / (R) Rear Door, Molding - Scratch &amp; Dent - Medium / Rear Bumper, Lamps, Panels - Scratch - Large / (L) Rear Fender, Molding - Dent - Minimal / (L) Rear Door, Molding - Scratch - Medium / (L) Front Door, Molding - Scratch &amp; Dent - Large / (L) Front Fender, Molding - Scratch &amp; Dent - Small / Bonnet, Headlight - Dent - Small / Member (Bolted) - Dent - Yes / Front Bumper, Grille, Lamps - Scratch - Large</p> |
