General Information

Make	Toyota	Model	Vios
YOM	2024	Odo Meter Reading	16,792
Registration No.	NHM4111	Chassis No.	PA1B18F36P4232028
CC	1.3	Transmission	CVT
Fuel Type	Gas	Type of Body	Sedan
Colour	Red

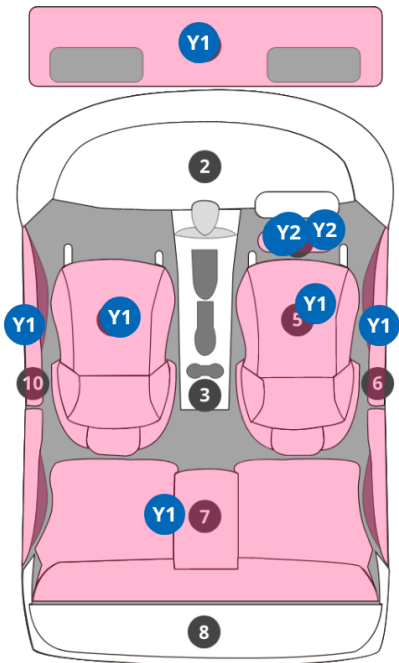
Interior Evaluation : B	Exterior Evaluation : C

<p>a : Cut, Fray d : Loose, Deformed k : Animal Hair s : Smell t : Cigarette Burns x : Defective y : Stain</p>

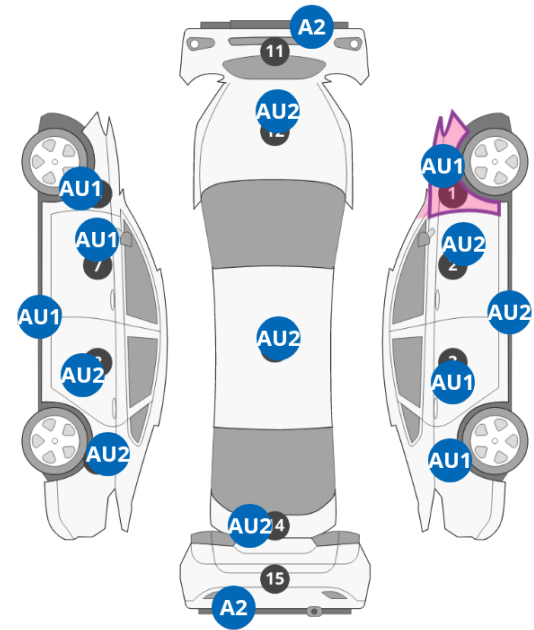
<p>A : Scratch AU : Scratch & Dent B : Modified C : Corrosion G : Stone chip P : Faded S : Rust SC : Rust & Corrosion U : Dent X : Defective Y : Crack, Gap</p>
<p>Remarks (L) Front Seat - Grime - Minimal / (R) Front Seat - Grime - Minimal / (L) Front Trim - Grime - Minimal / (R) Front Trim - Grime - Minimal / Rear Seat - Grime - Minimal / (L) Front Floor Mat - Grime - Small / (R) Front Floor Mat - Grime - Small / Mat Other - Grime - Small / Ceiling - Grime - Minimal</p>	<p>Remarks (L) Front Door, Molding - Scratch & Dent - Minimal / (L) Rear Door, Molding - Scratch & Dent - Small / (L) Rear Fender, Molding - Scratch & Dent - Small / Trunk Hood, Rear Gate - Scratch & Dent - Small / Rear Bumper, Lamps, Panels - Scratch - Small / (R) Rear Fender, Molding - Scratch & Dent - Minimal / (R) Rear Door, Molding - Scratch & Dent - Minimal / (R) Step, In-panel, Side Spoiler - Scratch & Dent - Small / (R) Front Door, Molding - Scratch & Dent - Small / (R) Front Fender, Molding - Scratch & Dent - Minimal / (R) Front Fender, Molding - Repair mark - Yes / Bonnet, Headlight - Scratch & Dent - Small / (L) Front Fender, Molding - Scratch & Dent - Minimal / (L) Step, In-panel, Side Spoiler - Scratch & Dent - Minimal / Roof - Scratch & Dent - Small / Front Bumper, Grille, Lamps - Scratch - Small</p>

<p>Inspector Notes</p>
<p>with LTO plate, with spare tire, with jack, with warranty booklet, scratches on taillight and headlight, no spare key, no reverse camera.</p>
