General Information

Make	Toyota	Model	Vios
YOM	2024	Odo Meter Reading	39,096
Registration No.	NHN9419	Chassis No.	PA1B18F36R4260614
CC	1.3	Transmission	CVT
Fuel Type	Gas	Type of Body	Sedan
Colour	Black

Body / Panel Condition

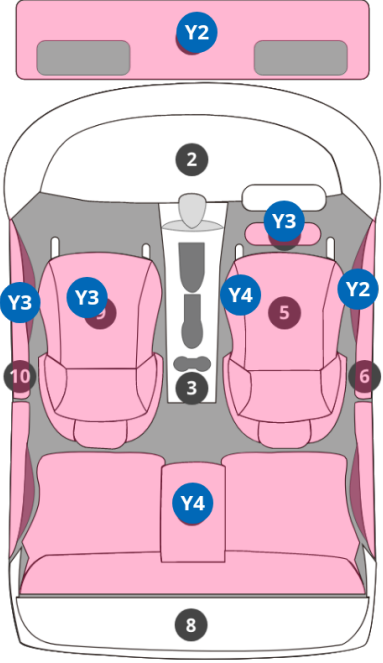
Interior Evaluation : C	Exterior Evaluation : E

<p>a : Cut, Fray d : Loose, Deformed k : Animal Hair s : Smell t : Cigarette Burns x : Defective y : Stain</p>

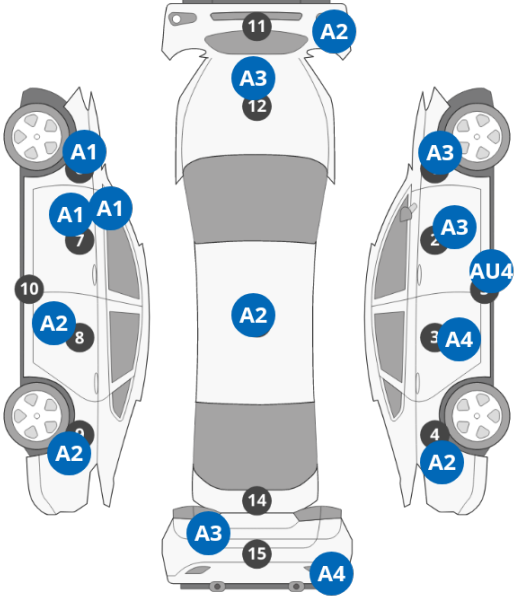
<p>A : Scratch AU : Scratch & Dent B : Modified C : Corrosion G : Stone chip P : Faded S : Rust SC : Rust & Corrosion U : Dent X : Defective Y : Crack, Gap</p>
<p>Remarks (R) Front Seat - Grime - Large / (R) Front Trim - Grime - Small / Rear Seat - Grime - Large / (L) Front Trim - Grime - Medium / (L) Front Seat - Grime - Medium / (L) Front Floor Mat - Grime - Medium / Ceiling - Grime - Small</p>	<p>Remarks Trunk Hood, Rear Gate - Scratch - Medium / Rear Bumper, Lamps, Panels - Scratch - Large / (R) Rear Fender, Molding - Scratch - Small / (R) Rear Door, Molding - Scratch - Large / (R) Front Door, Molding - Scratch - Medium / (R) Step, In-panel, Side Spoiler - Scratch & Dent - Large / (R) Front Fender, Molding - Scratch - Medium / Bonnet, Headlight - Scratch - Medium / Front Bumper, Grille, Lamps - Scratch - Small / (L) Front Fender, Molding - Scratch - Minimal / (L) Mirror - Scratch - Minimal / (L) Rear Door, Molding - Scratch - Small / (L) Front Door, Molding - Scratch - Minimal / (L) Rear Fender, Molding - Scratch - Small / Roof - Scratch - Small</p>
