General Information

Make	Toyota	Model	Vios
YOM	2024	Odo Meter Reading	40,347
Registration No.	NHQ2082	Chassis No.	PA1B18F31R4244272
CC	1.3	Transmission	CVT
Fuel Type	Gas	Type of Body	Sedan
Colour	Red Mica Metallic

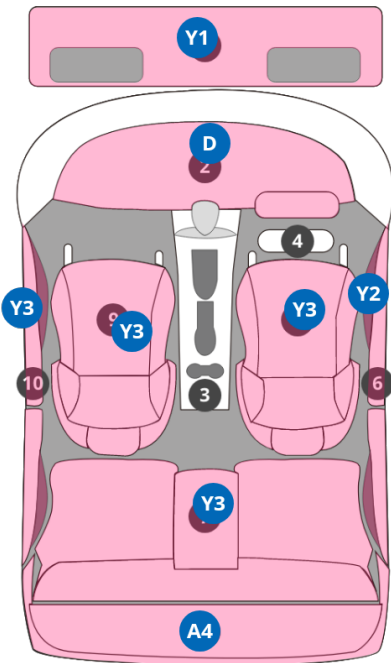
Interior Evaluation : C	Exterior Evaluation : E

<p>a : Cut, Fray d : Loose, Deformed k : Animal Hair s : Smell t : Cigarette Burns x : Defective y : Stain</p>

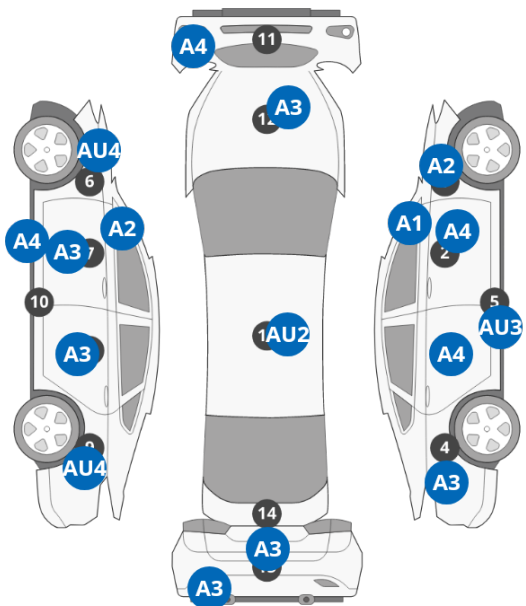
<p>A : Scratch AU : Scratch & Dent B : Modified C : Corrosion G : Stone chip P : Faded S : Rust SC : Rust & Corrosion U : Dent X : Defective Y : Crack, Gap</p>
<p>Remarks (R) Front Seat - Grime - Medium / (R) Front Trim - Grime - Small / Rear Seat - Grime - Medium / Trunk Room - Worn, Scratch, Cut, Crack - Large / (L) Front Trim - Grime - Medium / (L) Front Seat - Grime - Medium / Dashboard - Traces of Adhesive Tape - Yes / Ceiling - Grime - Minimal</p>	<p>Remarks (R) Front Fender - Repair Traces - Yes / (L) Rear Fender, Molding - Scratch & Dent - Large / (L) Rear Door, Molding - Scratch - Medium / (L) Mirror - Scratch - Small / (L) Front Door, Molding - Scratch - Medium / (L) Step, In-panel, Side Spoiler - Scratch - Large / (L) Front Fender, Molding - Scratch & Dent - Large / Front Bumper, Grille, Lamps - Scratch - Large / Bonnet, Headlight - Scratch - Medium / (R) Front Fender, Molding - Scratch - Small / (R) Mirror - Scratch - Minimal / (R) Front Door, Molding - Scratch - Large / (R) Step, In-panel, Side Spoiler - Scratch & Dent - Medium / (R) Rear Door, Molding - Scratch - Large / (R) Rear Fender, Molding - Scratch - Medium / Rear Bumper, Lamps, Panels - Scratch - Medium / Trunk Hood, Rear Gate - Scratch - Medium / Roof - Scratch & Dent - Small</p>
