General Information

Make	Toyota	Model	Innova
YOM	2024	Odo Meter Reading	22,277
Registration No.	NHQ3027	Chassis No.	PA2JA8EMXP0135332
CC	2.8	Transmission	A/T
Fuel Type	Diesel	Type of Body	Wagon
Colour	Red

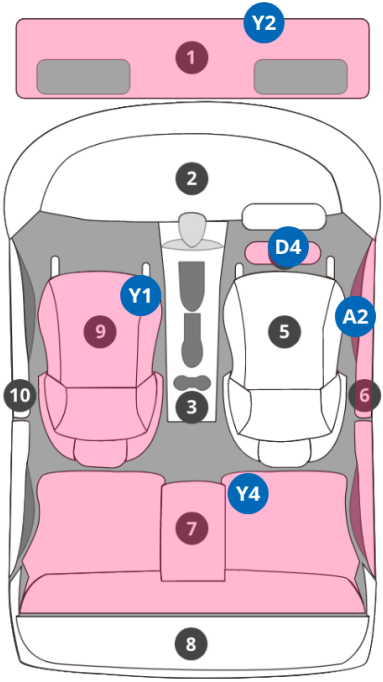
Interior Evaluation : C	Exterior Evaluation : C

<p>a : Cut, Fray d : Loose, Deformed k : Animal Hair s : Smell t : Cigarette Burns x : Defective y : Stain</p>

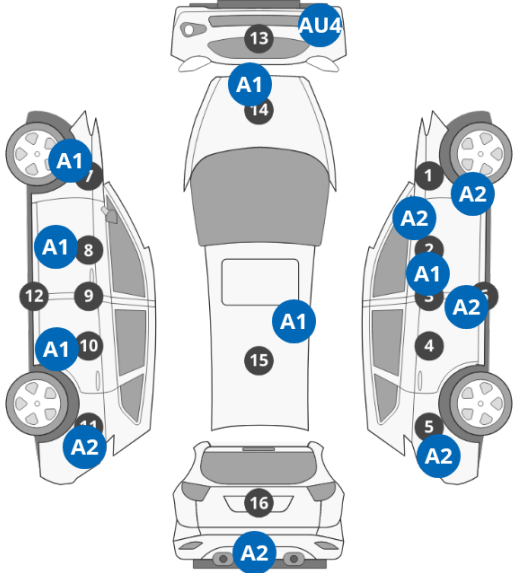
<p>A : Scratch AU : Scratch & Dent B : Modified C : Corrosion G : Stone chip P : Faded S : Rust SC : Rust & Corrosion U : Dent X : Defective Y : Crack, Gap</p>
<p>Remarks Ceiling - Grime - Small / (L) Front Floor Mat - Worked - Large / (R) Front Trim - Cut, Crack - Small / Rear Seat - Grime - Large / (L) Front Seat - Grime - Minimal</p>	<p>Remarks (R) Front Fender, Molding - Scratch - Small / (R) Mirror - Scratch - Small / (R) Front Door, Molding - Scratch - Minimal / (R) Rear Door, Molding - Scratch - Small / (R) Rear Fender, Molding - Scratch - Small / Rear Bumper, Lamps, Panels - Scratch - Small / (L) Rear Fender, Molding - Scratch - Small / (L) Rear Door, Molding - Scratch - Minimal / (L) Front Door, Molding - Scratch - Minimal / (L) Front Fender, Molding - Scratch - Minimal / Front Bumper, Grille, Lamps - Scratch & Dent - Large / Bonnet, Headlight - Scratch - Minimal / Roof - Scratch - Minimal</p>

<p>Inspector Notes</p>
<p>With LTO plate, with jack and tools, with spare tire, no warranty booklet, scratches on taillight</p>
