## General Information

<b>Make</b>	Toyota	<b>Model</b>	Innova
<b>YOM</b>	2025	<b>Odo Meter Reading</b>	32,286
<b>Registration No.</b>	NHS4763	<b>Chassis No.</b>	PA2JA8EM2R0144528
<b>CC</b>	2.8	<b>Transmission</b>	A/T
<b>Fuel Type</b>	Diesel	<b>Type of Body</b>	Wagon
<b>Colour</b>	Red

## Body / Panel Condition

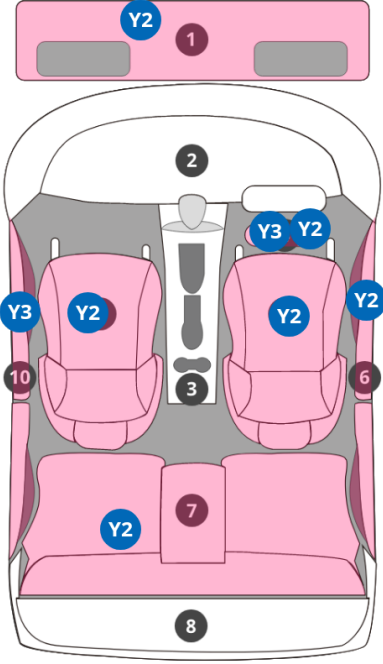
<b>Interior Evaluation :</b> <span style="color: red; font-weight: bold; font-size: 1.2em;">C</span>	<b>Exterior Evaluation :</b> <span style="color: red; font-weight: bold; font-size: 1.2em;">C</span>

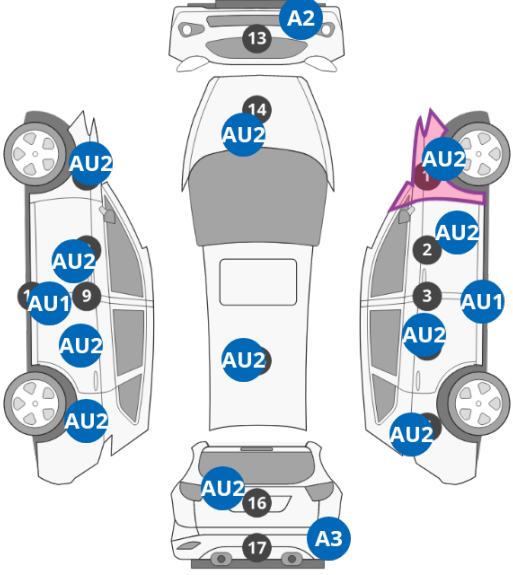
<p><b>A</b> : Scratch <b>AU</b> : Scratch &amp; Dent <b>B</b> : Modified <b>C</b> : Corrosion <b>G</b> : Stone chip <b>P</b> : Faded <b>S</b> : Rust <b>SC</b> : Rust &amp; Corrosion <b>U</b> : Dent <b>X</b> : Defective <b>Y</b> : Crack, Gap</p>
<p><b>Remarks</b> (L) Front Trim - Grime - Medium / (L) Front Floor Mat - Grime - Medium / (R) Front Floor Mat - Grime - Small / (L) Front Seat - Grime - Small / (R) Front Seat - Grime - Small / Rear Seat - Grime - Small / Ceiling - Grime - Small / (R) Front Trim - Grime - Small</p>	<p><b>Remarks</b> (L) Front Fender, Molding - Scratch &amp; Dent - Small / Bonnet, Headlight - Scratch &amp; Dent - Small / Front Bumper, Grille, Lamps - Scratch - Small / (R) Front Fender, Molding - Repair mark - Yes / (R) Front Fender, Molding - Scratch &amp; Dent - Small / (R) Front Door, Molding - Scratch &amp; Dent - Small / (R) Rear Door, Molding - Scratch &amp; Dent - Small / (R) Rear Fender, Molding - Scratch &amp; Dent - Small / Trunk Hood, Rear Gate - Scratch &amp; Dent - Small / Rear Bumper, Lamps, Panels - Scratch - Medium / (L) Rear Fender, Molding - Scratch &amp; Dent - Small / (L) Rear Door, Molding - Scratch &amp; Dent - Small / (L) Front Door, Molding - Scratch &amp; Dent - Small / Roof - Scratch &amp; Dent - Small</p>
