## General Information

| Make | Toyota | Model | Vios |
| YOM | 2023 | Mileage | 24,112 |
| Registration No. | BAF3541 | Chassis No. | PA1B18F32P4219944 |

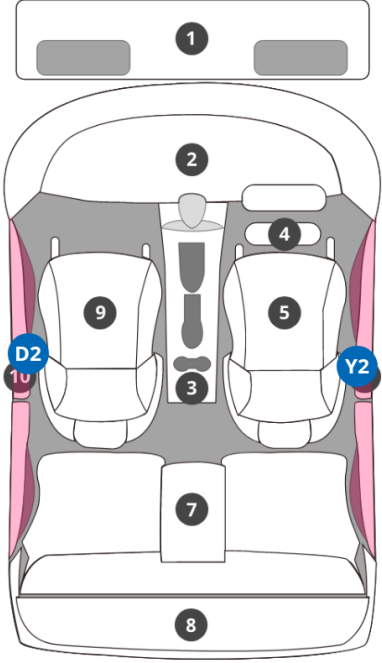
| <b>Remarks</b><br>(R) Front Trim - Grime - Small / (L) Front Trim - Crinkle - Small | <b>Remarks</b><br>Bonnet, Headlight - Scratch & Dent - Medium / (R) Mirror - Scratch - Small / (R) Rear Door, Molding - Scratch - Small / (R) Rear Fender, Molding - Scratch - Small / Rear Bumper, Lamps, Panels - Scratch & Dent - Medium / Roof Spoiler, Molding - Scratch - Small / (L) Front Door, Molding - Scratch & Dent - Small / (L) Front Fender, Molding - Scratch - Minimal / Front Bumper, Grille, Lamps - Scratch - Medium |
