## General Information

<b>Make</b>	Toyota	<b>Model</b>	Vios
<b>YOM</b>	2025	<b>Odo Meter Reading</b>	15,266
<b>Registration No.</b>	NHU6294	<b>Chassis No.</b>	PA1B18F36R4275002
<b>CC</b>	1.3	<b>Transmission</b>	CVT
<b>Fuel Type</b>	Gas	<b>Type of Body</b>	Sedan
<b>Colour</b>	Red Mica Metallic

## Body / Panel Condition

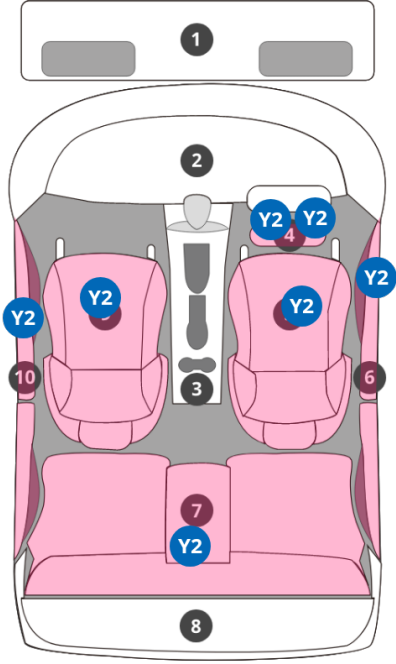
<b>Interior Evaluation :</b> <span style="float: right;"><b>B</b></span>	<b>Exterior Evaluation :</b> <span style="float: right;"><b>D</b></span>

<p><b>a</b> : Cut, Fray <b>d</b> : Loose, Deformed <b>k</b> : Animal Hair <b>s</b> : Smell <b>t</b> : Cigarette Burns <b>x</b> : Defective <b>y</b> : Stain</p>

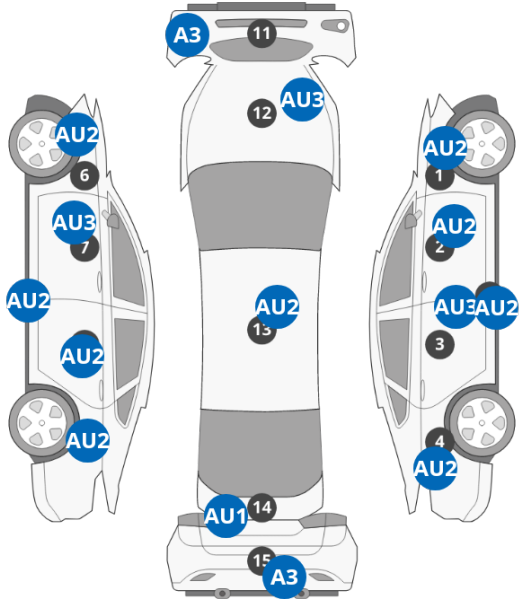
<p><b>A</b> : Scratch <b>AU</b> : Scratch &amp; Dent <b>B</b> : Modified <b>C</b> : Corrosion <b>G</b> : Stone chip <b>P</b> : Faded <b>S</b> : Rust <b>SC</b> : Rust &amp; Corrosion <b>U</b> : Dent <b>X</b> : Defective <b>Y</b> : Crack, Gap</p>
<p><b>Remarks</b> (L) Front Seat - Grime - Small / (R) Front Seat - Grime - Small / Rear Seat - Grime - Small / (L) Front Floor Mat - Grime - Small / (R) Front Floor Mat - Grime - Small / (L) Front Trim - Grime - Small / (R) Front Trim - Grime - Small</p>	<p><b>Remarks</b> Roof - Scratch &amp; Dent - Small / (L) Rear Door, Molding - Scratch &amp; Dent - Small / (L) Rear Fender, Molding - Scratch &amp; Dent - Small / (L) Front Door, Molding - Scratch &amp; Dent - Medium / (L) Front Fender, Molding - Scratch &amp; Dent - Small / Front Bumper, Grille, Lamps - Scratch - Medium / Bonnet, Headlight - Scratch &amp; Dent - Medium / (R) Front Door, Molding - Scratch &amp; Dent - Small / (R) Front Fender, Molding - Scratch &amp; Dent - Small / (R) Rear Door, Molding - Scratch &amp; Dent - Medium / (R) Rear Fender, Molding - Scratch &amp; Dent - Small / Trunk Hood, Rear Gate - Scratch &amp; Dent - Minimal / Rear Bumper, Lamps, Panels - Scratch - Medium / (R) Step, In-panel, Side Spoiler - Scratch &amp; Dent - Small</p>

<p><b>Inspector Notes</b></p>
<p>with LTO plate, with spare tire with reverse camera, with spare key, no warranty and manual booklet, scratches on taillight and headlight, no tools and jack.</p>
