## General Information

<b>Make</b>	Toyota	<b>Model</b>	Raize
<b>YOM</b>	2025	<b>Odo Meter Reading</b>	8,918
<b>Registration No.</b>	NKK4652	<b>Chassis No.</b>	MHKAA1BA0RJ136008
<b>CC</b>	1.0	<b>Transmission</b>	CVT
<b>Fuel Type</b>	Gas	<b>Type of Body</b>	SUV
<b>Colour</b>	Black

## Body / Panel Condition

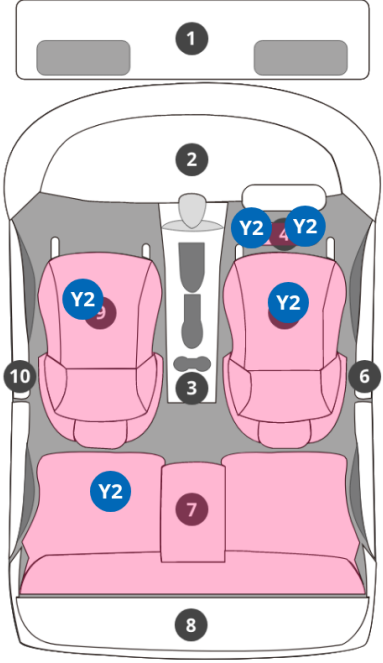
<b>Interior Evaluation :</b> <span style="color: red; font-weight: bold; font-size: 1.2em;">A</span>	<b>Exterior Evaluation :</b> <span style="color: red; font-weight: bold; font-size: 1.2em;">C</span>

<p><b>a</b> : Cut, Fray <b>d</b> : Loose, Deformed <b>k</b> : Animal Hair <b>s</b> : Smell <b>t</b> : Cigarette Burns <b>x</b> : Defective <b>y</b> : Stain</p>

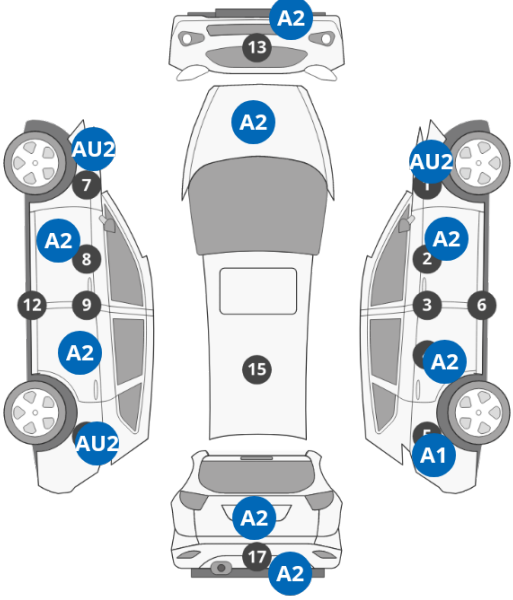
<p><b>A</b> : Scratch <b>AU</b> : Scratch &amp; Dent <b>B</b> : Modified <b>C</b> : Corrosion <b>G</b> : Stone chip <b>P</b> : Faded <b>S</b> : Rust <b>SC</b> : Rust &amp; Corrosion <b>U</b> : Dent <b>X</b> : Defective <b>Y</b> : Crack, Gap</p>
<p><b>Remarks</b> (L) Front Seat - Grime - Small / (R) Front Seat - Grime - Small / (R) Front Floor Mat - Grime - Small / (L) Front Floor Mat - Grime - Small</p>	<p><b>Remarks</b> (L) Rear Fender, Molding - Scratch &amp; Dent - Small / (L) Front Fender, Molding - Scratch &amp; Dent - Small / (R) Front Fender, Molding - Scratch &amp; Dent - Small / Front Bumper, Grille, Lamps - Scratch - Small / Rear Bumper, Lamps, Panels - Scratch - Small / Trunk Hood, Rear Gate - Scratch - Small / (L) Rear Door, Molding - Scratch - Small / (L) Front Door, Molding - Scratch - Small / (R) Front Door, Molding - Scratch - Small / (R) Rear Door, Molding - Scratch - Small / (R) Rear Fender, Molding - Scratch - Minimal / Bonnet, Headlight - Scratch - Small</p>

<p><b>Inspector Notes</b></p>
<p>with LTO plate, with spare tire, with jack, with reverse camera, with manual and warranty booklet, scratches on taillight and headlight.</p>
