General Information

Make	Toyota	Model	Avanza
YOM	2025	Odo Meter Reading	4,379
Registration No.	NKQ5786	Chassis No.	MHFAA1BY0S0043173
CC	1.3	Transmission	CVT
Fuel Type	Gas	Type of Body	Wagon
Colour	Black

Body / Panel Condition

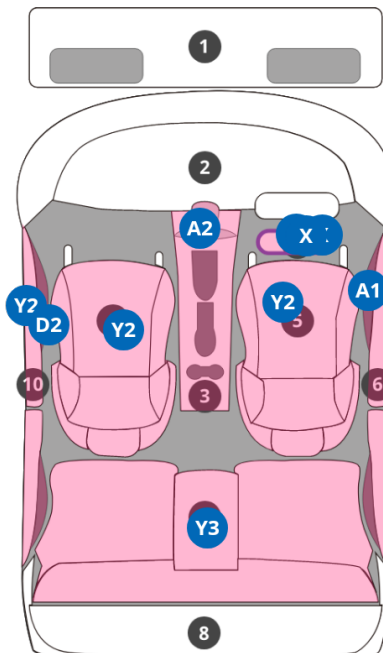
Interior Evaluation : B	Exterior Evaluation : E

<p>a : Cut, Fray d : Loose, Deformed k : Animal Hair s : Smell t : Cigarette Burns x : Defective y : Stain</p>

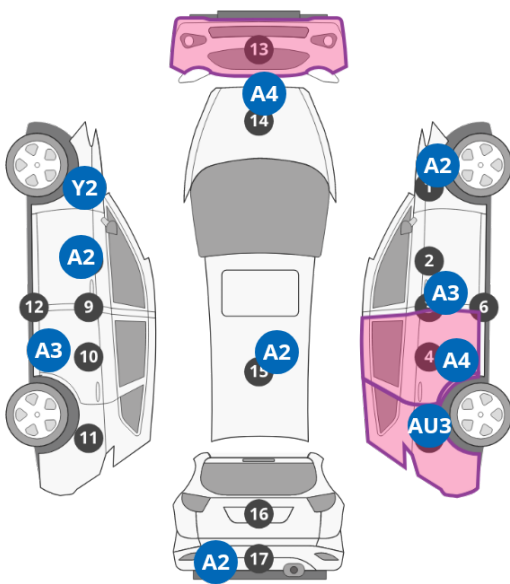
<p>A : Scratch AU : Scratch & Dent B : Modified C : Corrosion G : Stone chip P : Faded S : Rust SC : Rust & Corrosion U : Dent X : Defective Y : Crack, Gap</p>
<p>Remarks (R) Front Floor Mat - Missing - Yes / (L) Front Floor Mat - Missing - Yes / Console, Switchs, Vents - Worn, Scratch, Cut, Crack - Small / (R) Front Trim - Cut, Crack - Minimal / (L) Front Trim - Grime - Small / Rear Seat - Grime - Medium / (L) Rear Trim - Worked - Small / (R) Front Seat - Grime - Small / (L) Front Seat - Grime - Small / Mat Other - Missing - Yes</p>	<p>Remarks (R) Rear Fender - Repair Traces - Yes / (R) Rear Door - Repair Traces - Yes / (R) Front Fender, Molding - Scratch - Small / (R) Front Door, Molding - Scratch - Medium / (R) Rear Door, Molding - Scratch - Large / (R) Rear Fender, Molding - Scratch & Dent - Medium / Rear Bumper, Lamps, Panels - Scratch - Small / (L) Rear Door, Molding - Scratch - Medium / (L) Front Door, Molding - Scratch - Small / (R) Rear Door, Molding - Repair mark - Yes / (R) Rear Fender, Molding - Repair mark - Yes / Front Bumper, Grille, Lamps - Repair mark - Yes / (L) Front Fender, Molding - Crack, Gap - Small / Bonnet, Headlight - Scratch - Large / Roof - Scratch - Small</p>
