## General Information

| Make | Toyota | Model | Vios |
| Registration No. | GBJ1865 | Chassis No. | PA1B18F36R4279180 |

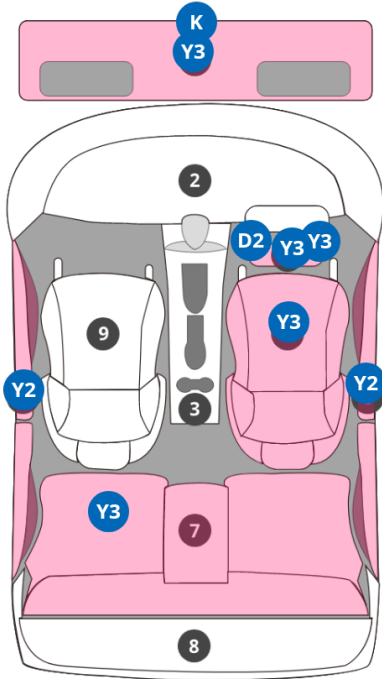
| Interior Evaluation : <b>C</b> | Exterior Evaluation : <b>E</b> |
|---|---|
| <p><b>a</b> : Cut, Fray <b>d</b> : Loose, Deformed <b>k</b> : Animal Hair <b>s</b> : Smell <b>t</b> : Cigarette Burns <b>x</b> : Defective <b>y</b> : Stain</p> | <p><b>A</b> : Scratch <b>AU</b> : Scratch &amp; Dent <b>B</b> : Modified <b>C</b> : Corrosion <b>G</b> : Stone chip <b>P</b> : Faded <b>S</b> : Rust <b>SC</b> : Rust &amp; Corrosion <b>U</b> : Dent <b>X</b> : Defective <b>Y</b> : Crack, Gap</p> |
| <p><b>Remarks</b></p> <p>Overall Interior - Animal Hair - Yes / Ceiling - Grime - Medium / (R) Front Trim - Grime - Small / (R) Front Seat - Grime - Medium / (R) Front Floor Mat - Grime - Medium / Mat Other - Grime - Medium / Rear Seat - Grime - Medium / (L) Front Trim - Grime - Small / (L) Front Floor Mat - Worked - Small</p> | <p><b>Remarks</b></p> <p>(R) Front Fender, Molding - Scratch - Medium / (R) Mirror - Scratch - Small / (R) Front Door, Molding - Scratch - Large / (R) Step, In-panel, Side Spoiler - Scratch - Small / (R) Rear Door, Molding - Scratch - Large / (R) Rear Fender, Molding - Scratch - Large / Trunk Hood, Rear Gate - Scratch - Medium / Rear Bumper, Lamps, Panels - Scratch &amp; Dent - Medium / (L) Rear Fender, Molding - Scratch - Small / (L) Rear Door, Molding - Scratch &amp; Dent - Large / (L) Step, In-panel, Side Spoiler - Scratch &amp; Dent - Medium / (L) Mirror - Scratch - Small / (L) Front Door, Molding - Scratch - Small / (L) Front Fender, Molding - Scratch &amp; Dent - Medium / Front Bumper, Grille, Lamps - Scratch &amp; Dent - Large / Bonnet, Headlight - Scratch - Medium / Roof - Scratch - Small</p> |
