## General Information

| Make | Toyota | Model | Wigo |
| Registration No. | GBJ8341 | Chassis No. | MHKAA1BC4SJ036243 |

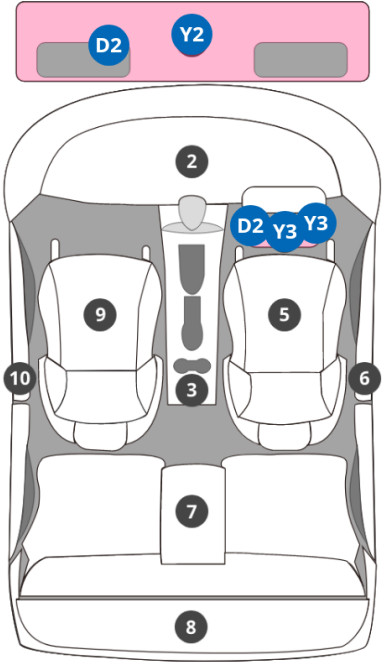
| Interior Evaluation : <span style="color: red; font-weight: bold;">B</span> | Exterior Evaluation : <span style="color: red; font-weight: bold;">D</span> |
| <b>Remarks</b><br>(R) Front Floor Mat - Grime - Medium / Sunvisor, Sunglass Holder - Crinkle - Small / Ceiling - Grime - Small / Mat Other - Grime - Medium / (L) Front Floor Mat - Worked - Small | <b>Remarks</b><br>(R) Front Fender, Molding - Scratch - Small / (R) Mirror - Scratch - Small / (R) Rear Door, Molding - Scratch - Minimal / (R) Front Door, Molding - Scratch - Small / (R) Rear Fender, Molding - Scratch - Small / Trunk Hood, Rear Gate - Scratch - Minimal / Rear Bumper, Lamps, Panels - Scratch & Dent - Small / (L) Rear Fender, Molding - Scratch - Small / (L) Front Door, Molding - Scratch - Medium / (L) Step, In-panel, Side Spoiler - Scratch - Minimal / (L) Rear Door, Molding - Scratch - Minimal / (L) Front Fender, Molding - Scratch - Small / Bonnet, Headlight - Scratch - Small / Front Bumper, Grille, Lamps - Repair mark - Yes / Front Bumper, Grille, Lamps - Scratch & Dent - Large / Roof - Scratch - Minimal |
