General Information

Make	Mitsubishi	Model	Mirage
YOM	2020	Odo Meter Reading	34,000
Registration No.	NGT5659	Chassis No.	PAEA13RXLLA012357
CC	1.2	Transmission	A/T
Fuel Type	Gas	Type of Body	Sedan
Colour	Black

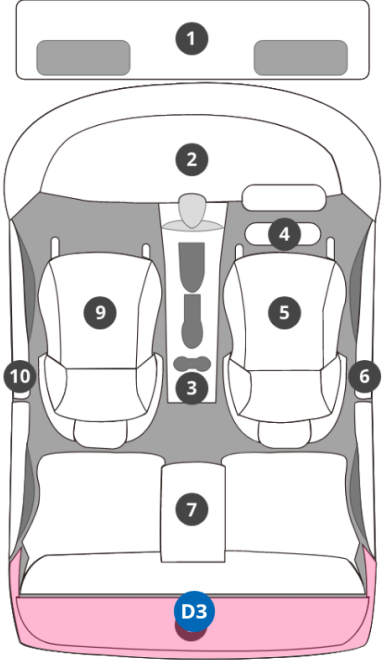
Interior Evaluation : B	Exterior Evaluation : C

<p>a : Cut, Fray d : Loose, Deformed k : Animal Hair s : Smell t : Cigarette Burns x : Defective y : Stain</p>

Inspector Notes	
With Lto plate, with jack, 1key, no warranty booklet, no spare tire and tools, scratches on headlights and taillights, cover under trunk missing

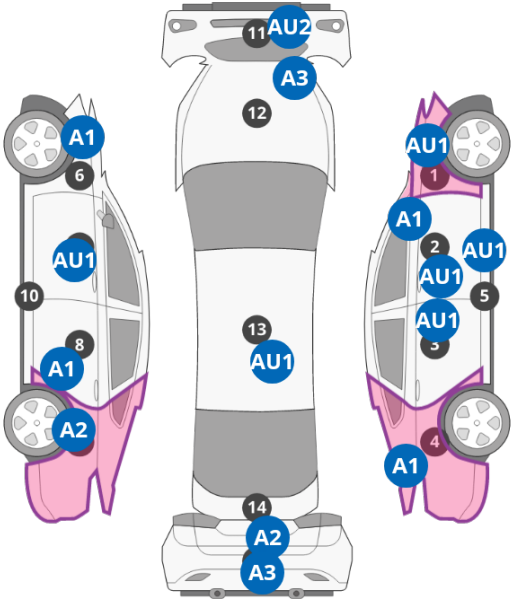
<p>A : Scratch AU : Scratch & Dent B : Modified C : Corrosion G : Stone chip P : Faded S : Rust SC : Rust & Corrosion U : Dent X : Defective Y : Crack, Gap</p>
Remarks Trunk Room - Loose, Deformed - Medium	Remarks (R) Rear Fender - Repair Traces - Yes / (R) Front Fender, Molding - Repair mark - Yes / (R) Front Fender, Molding - Scratch & Dent - Minimal / (R) Front Door, Molding - Scratch & Dent - Minimal / (R) Rear Door, Molding - Scratch & Dent - Minimal / (R) Step, In-panel, Side Spoiler - Scratch & Dent - Minimal / (R) Mirror - Scratch - Minimal / (R) Rear Fender, Molding - Repair mark - Yes / (R) Rear Fender, Molding - Scratch - Minimal / Roof - Scratch & Dent - Minimal / Trunk Hood, Rear Gate - Scratch - Small / Rear Bumper, Lamps, Panels - Scratch - Medium / (L) Rear Fender, Molding - Repair mark - Yes / (L) Rear Fender, Molding - Scratch - Small / (L) Rear Door, Molding - Scratch - Minimal / (L) Front Door, Molding - Scratch & Dent - Minimal / (L) Front Fender, Molding - Scratch - Minimal / Bonnet, Headlight - Scratch - Medium / Front Bumper, Grille, Lamps - Scratch & Dent - Small
