General Information

Make	Toyota	Model	Hilux
YOM	2019	Odo Meter Reading	78,703
Registration No.	GAM1206	Chassis No.	MR0GB8DD5K1346614
CC	2.4	Transmission	M/T
Fuel Type	Diesel	Type of Body	Pickup
Colour	Gray

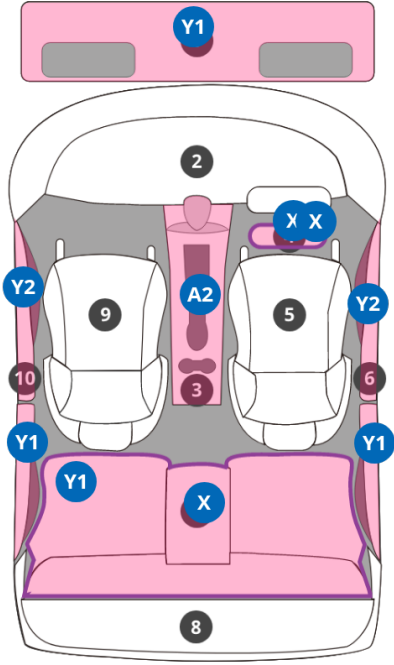
Interior Evaluation : C	Exterior Evaluation : C

<p>a : Cut, Fray d : Loose, Deformed k : Animal Hair s : Smell t : Cigarette Burns x : Defective y : Stain</p>

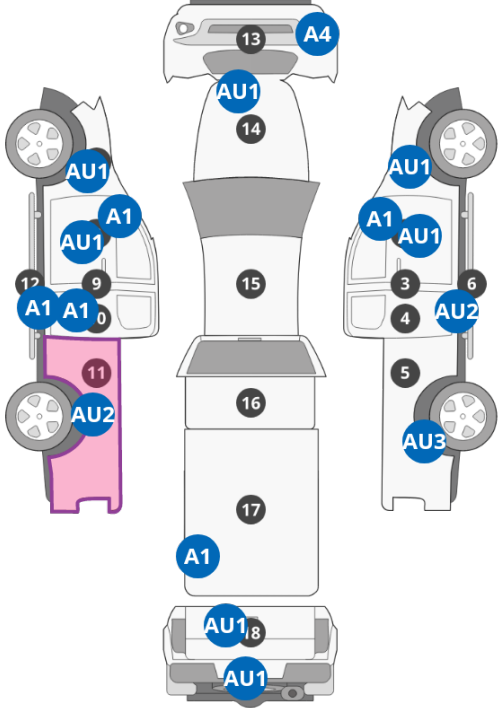
<p>A : Scratch AU : Scratch & Dent B : Modified C : Corrosion G : Stone chip P : Faded S : Rust SC : Rust & Corrosion U : Dent X : Defective Y : Crack, Gap</p>
<p>Remarks (L) Front Floor Mat - Missing - Yes / Mat Other - Missing - Yes / Ceiling - Grime - Minimal / Console, Switchs, Vents - Worn, Scratch, Cut, Crack - Small / Rear Seat - Grime - Minimal / Rear Seat Head Rest - Partially Missing - Yes / (R) Front Trim - Grime - Small / (L) Front Trim - Grime - Small / (L) Rear Trim - Grime - Minimal / (R) Rear Trim - Grime - Minimal</p>	<p>Remarks (R) Front Fender, Molding - Scratch & Dent - Minimal / (R) Mirror - Scratch - Minimal / (R) Front Door, Molding - Scratch & Dent - Minimal / (R) Step, In-panel, Side Spoiler - Scratch & Dent - Small / (R) Side Gate - Scratch & Dent - Medium / Rear Gate - Scratch & Dent - Minimal / Rear Bumper, Lamps, Panels - Scratch & Dent - Minimal / (L) Side Gate - Repair mark - Difference in Color / (L) Side Gate - Scratch & Dent - Small / (L) Rear Door, Molding - Scratch - Minimal / Roof - Scratch - Minimal / (L) Step, In-panel, Side Spoiler - Scratch - Minimal / (L) Mirror - Scratch - Minimal / (L) Front Door, Molding - Scratch & Dent - Minimal / (L) Front Fender, Molding - Scratch & Dent - Minimal / Front Bumper, Grille, Lamps - Scratch - Large / Bonnet, Headlight - Scratch & Dent - Minimal</p>
