## General Information

<b>Make</b>	Toyota	<b>Model</b>	Vios
<b>YOM</b>	2024	<b>Odo Meter Reading</b>	43,992
<b>Registration No.</b>	FAQ2987	<b>Chassis No.</b>	PA1B18F34P4228712
<b>CC</b>	1.3	<b>Transmission</b>	CVT
<b>Fuel Type</b>	Gas	<b>Type of Body</b>	Sedan
<b>Colour</b>	Red

## Overall Evaluation :

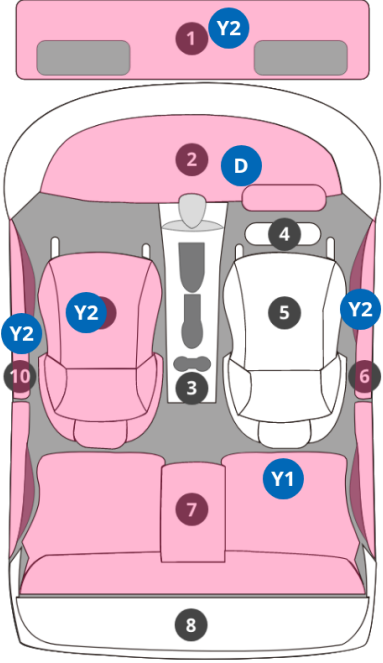
<p><b>a</b> : Cut, Fray <b>d</b> : Loose, Deformed <b>k</b> : Animal Hair <b>s</b> : Smell <b>t</b> : Cigarette Burns <b>x</b> : Defective <b>y</b> : Stain</p>

<p><b>A</b> : Scratch <b>AU</b> : Scratch &amp; Dent <b>B</b> : Modified <b>C</b> : Corrosion <b>G</b> : Stone chip <b>P</b> : Faded <b>S</b> : Rust <b>SC</b> : Rust &amp; Corrosion <b>U</b> : Dent <b>X</b> : Defective <b>Y</b> : Crack, Gap</p>
<p><b>Remarks</b> (L) Front Seat - Grime - Small / (R) Front Trim - Grime - Small / Rear Seat - Grime - Minimal / Dashboard - Traces of Adhesive Tape - Yes / Ceiling - Grime - Small / (L) Front Trim - Grime - Small</p>	<p><b>Remarks</b> Bonnet, Headlight - Dent - Small / Rear Bumper, Lamps, Panels - Scratch &amp; Dent - Medium / (L) Rear Door, Molding - Scratch - Small / (L) Front Door, Molding - Scratch - Medium / Front Bumper, Grille, Lamps - Scratch - Medium</p>
