General Information

Make	Toyota	Model	Vios
YOM	2024	Odo Meter Reading	19,750
Registration No.	FAR4340	Chassis No.	PA1B18F34R4247800
CC	1.3	Transmission	CVT
Fuel Type	Gas	Type of Body	Sedan
Colour	Silver

Body / Panel Condition

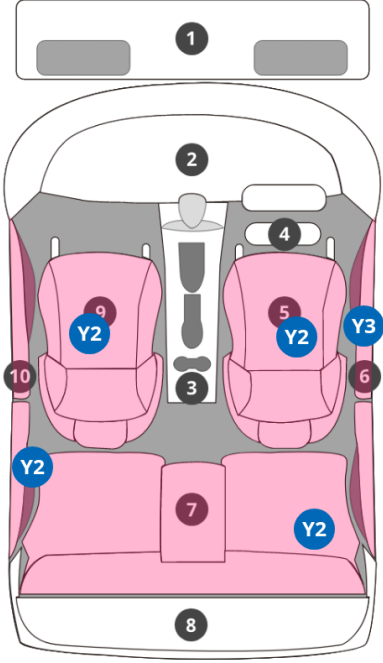
Interior Evaluation : B	Exterior Evaluation : D

<p>a : Cut, Fray d : Loose, Deformed k : Animal Hair s : Smell t : Cigarette Burns x : Defective y : Stain</p>

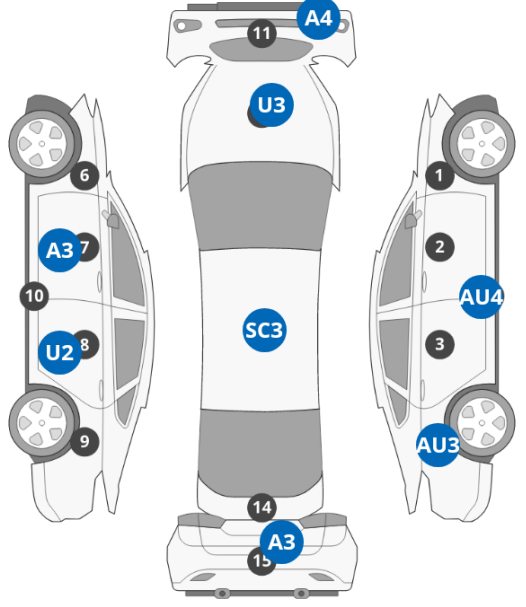
<p>A : Scratch AU : Scratch & Dent B : Modified C : Corrosion G : Stone chip P : Faded S : Rust SC : Rust & Corrosion U : Dent X : Defective Y : Crack, Gap</p>
<p>Remarks (R) Front Trim - Grime - Medium / (R) Front Seat - Grime - Small / (L) Front Seat - Grime - Small / Rear Seat - Grime - Small / (L) Rear Trim - Grime - Small</p>	<p>Remarks (R) Front Door, Molding - Scratch & Dent - Large / (R) Rear Fender, Molding - Scratch & Dent - Medium / (L) Front Door, Molding - Scratch - Medium / (L) Rear Door, Molding - Dent - Small / Trunk Hood, Rear Gate - Scratch - Medium / Front Bumper, Grille, Lamps - Scratch - Large / Bonnet, Headlight - Dent - Medium / Roof - Rust, Corrosion - Medium</p>
Frame Evaluation : A	Functional Evaluation : B
